# Roadblocks to Seagrass Recovery: Seagrass Restoration Planning

Pensacola Beach, January 29, 2016

## Project Goals:

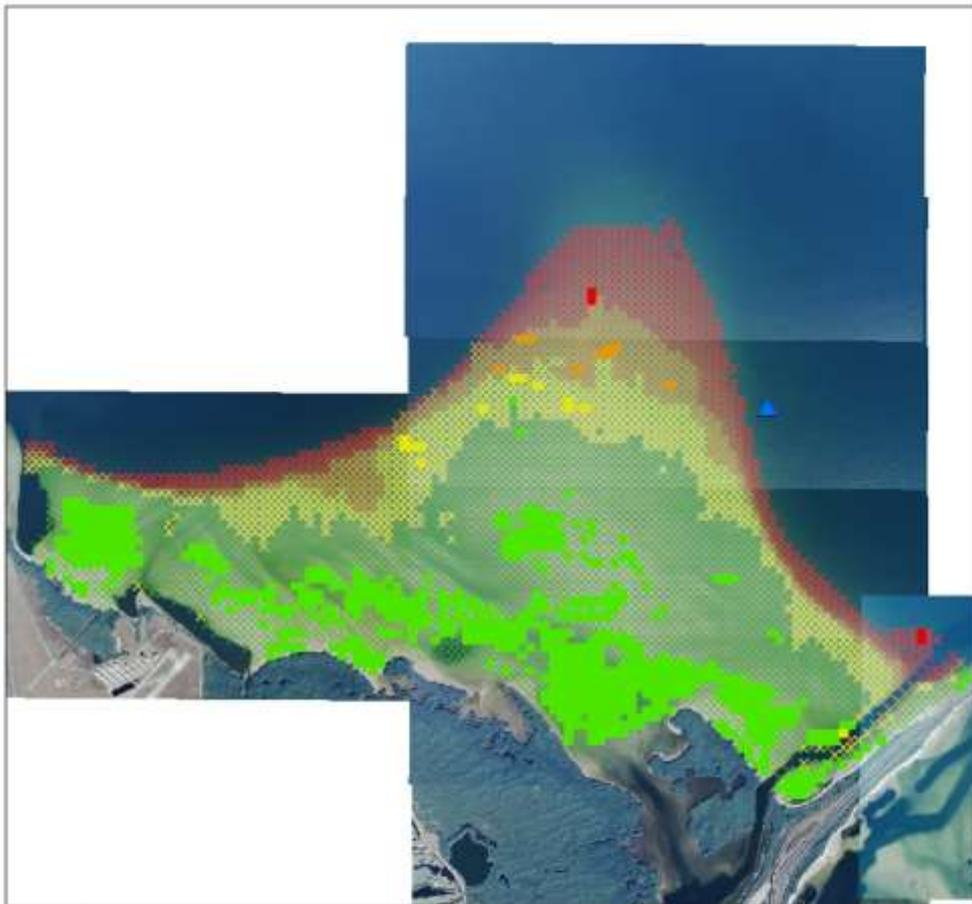
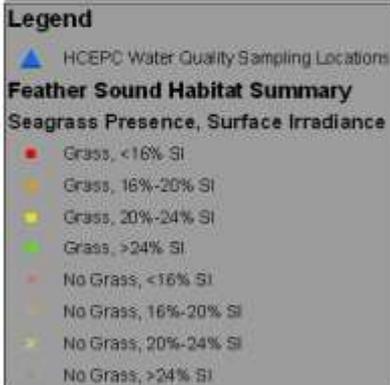
# Example of Grid-Based Modeling Approach- Feather Sound, Tampa Bay

## Inputs:

- HCEPC Water Quality Data
- Bathymetry Data
- Seagrass aerial photos

Process: Use OWQ data to calculate transparency and bathymetry to calculate light availability (%SI).

Result- Critical assessment of minimum light requirement for Shoalgrass- *Halodule wrightii*

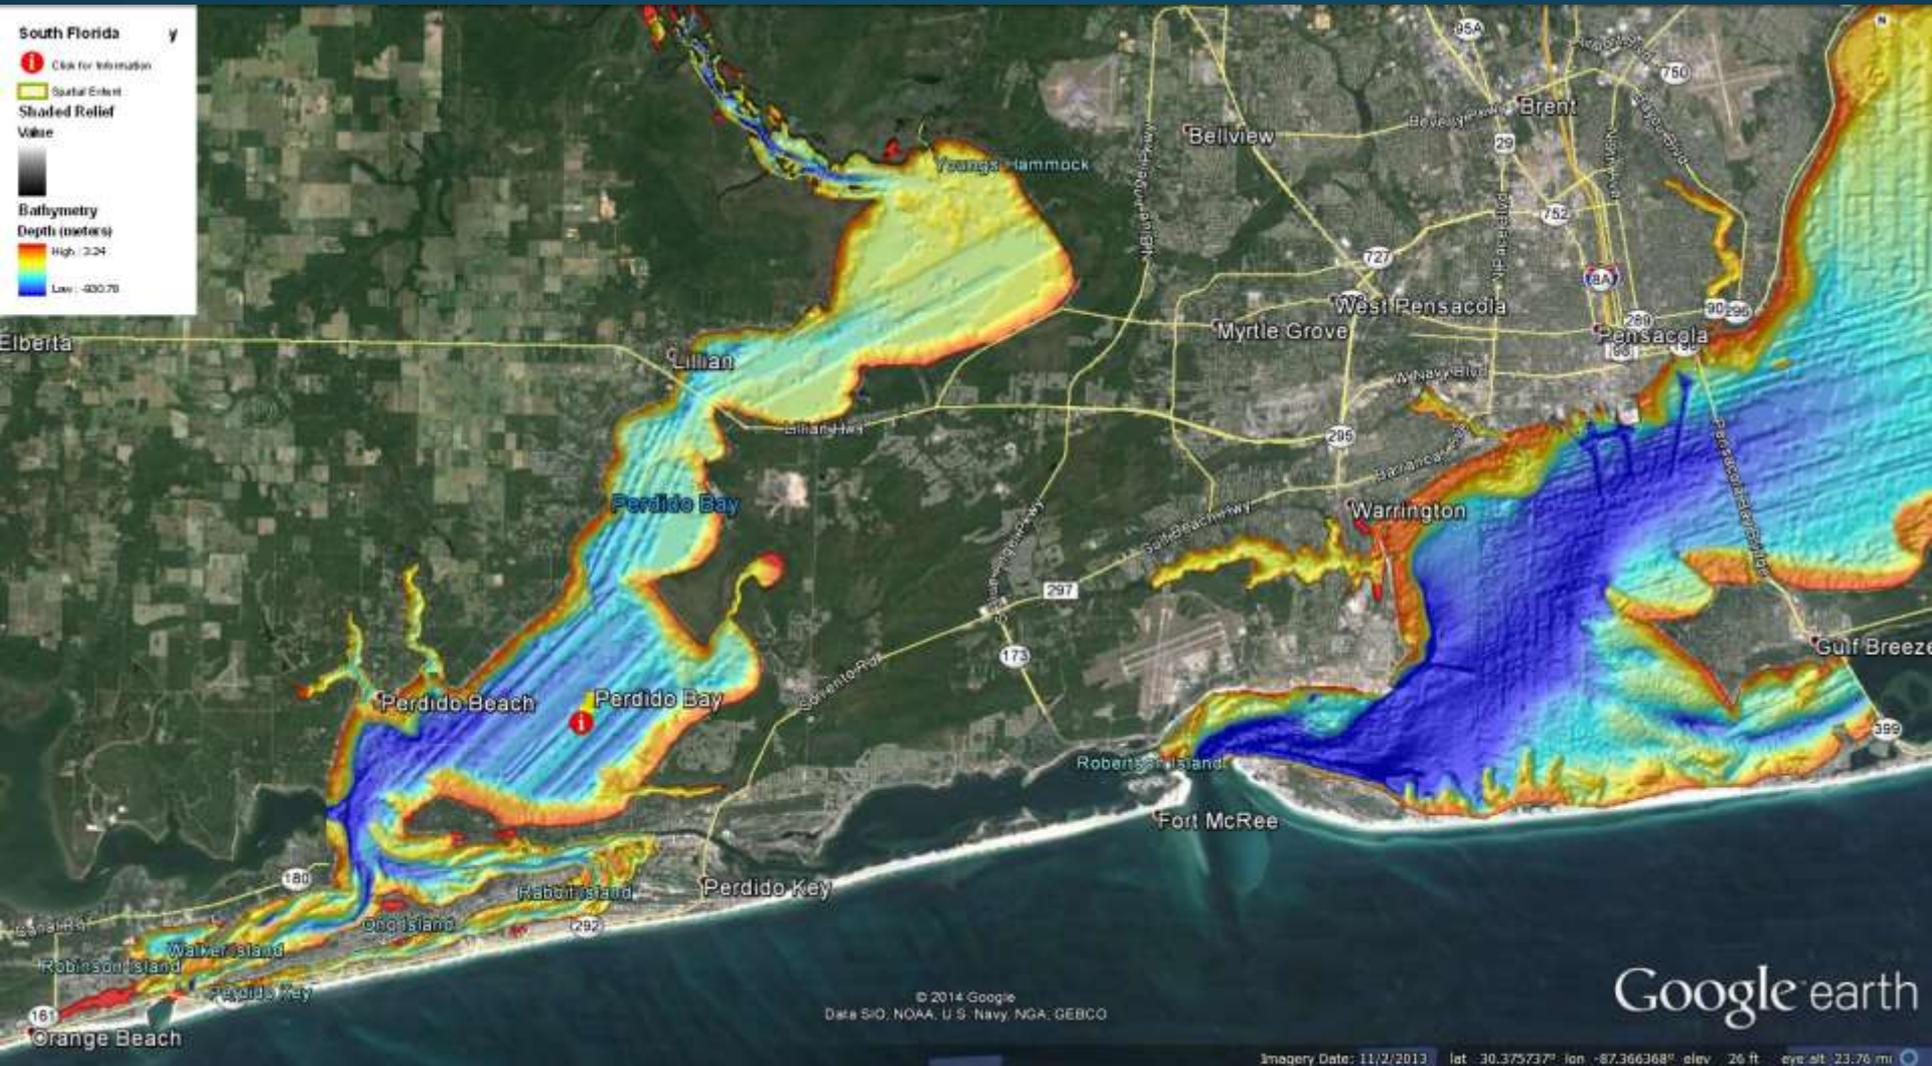
# First Input Data Layer- NOAA Bathymetry

Statistics of Perdido\_Model\_Bathy3m

Count: 8477  
Minimum: -10.51  
Maximum: 0.3  
Sum: -15817.08996  
Mean: -1.865883  
Standard Deviation: 1.153655  
Nulls: 0

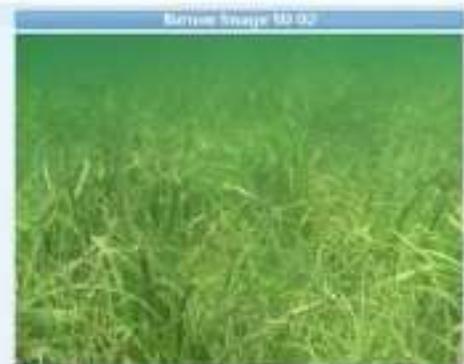
This is an image representation of the Bottoms of Station SU 02. It is described as "SEEDP" which is explained to the left in the "Bottom Type" Section. Click on this image to open a larger image.

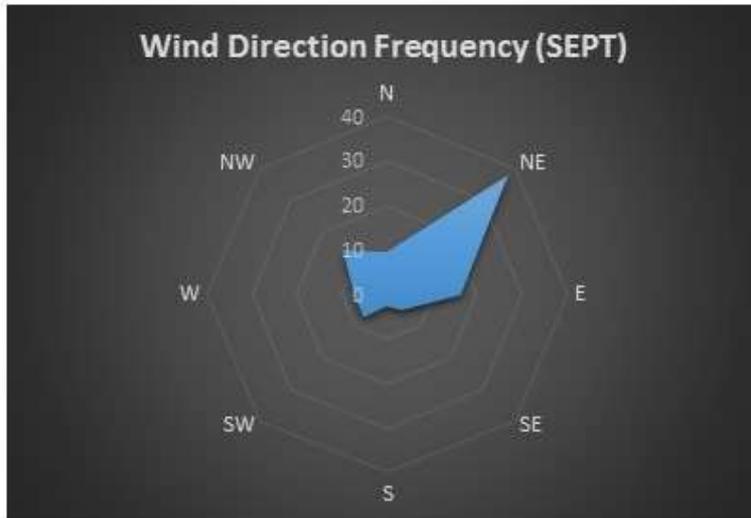
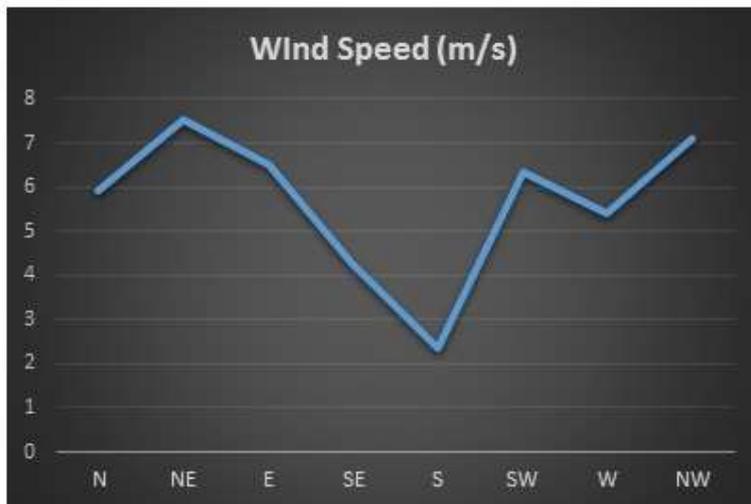
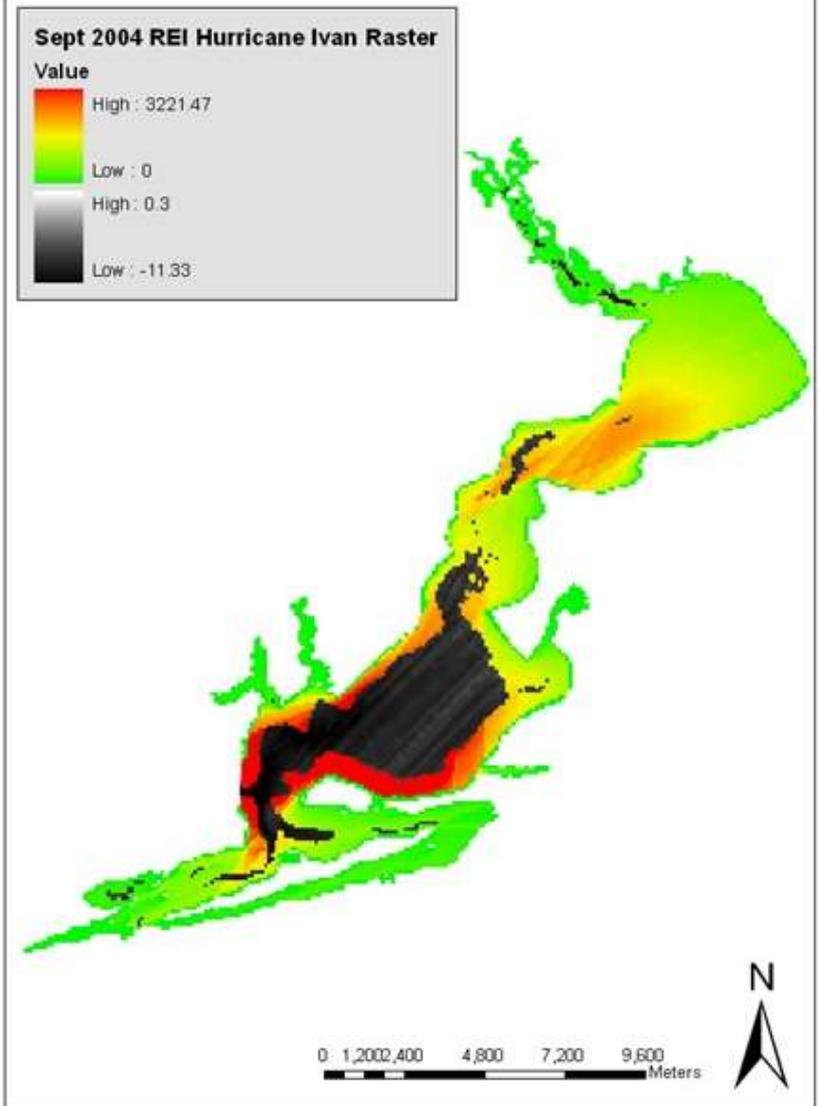
# NOAA Physical Disturbance Model (WEMo)- Perdido Bay, September 2004

## Hurricane Ivan

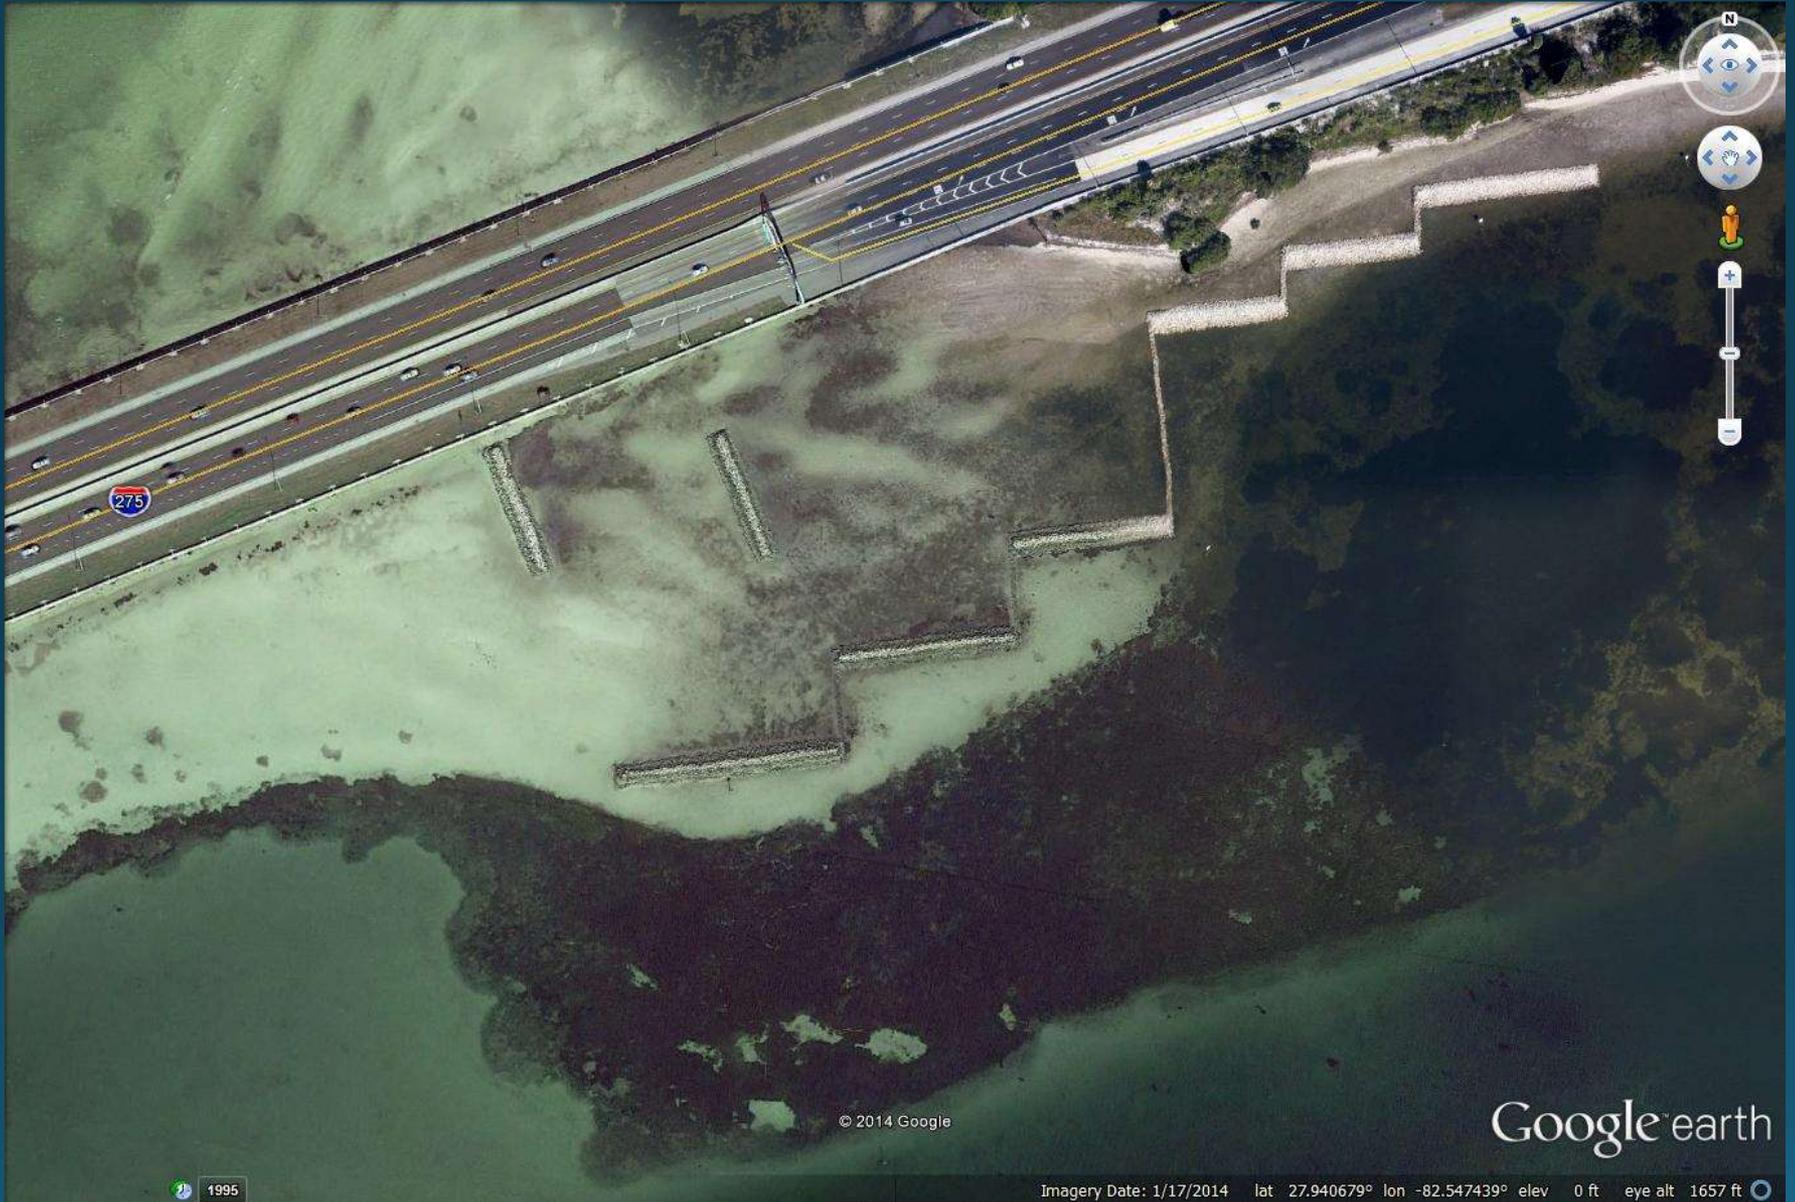
# Effect of Rip Rap Barriers, January 2014

Imagery Date: 1/17/2014 lat 27.940679° lon -82.547439° elev 0 ft eye alt 1657 ft

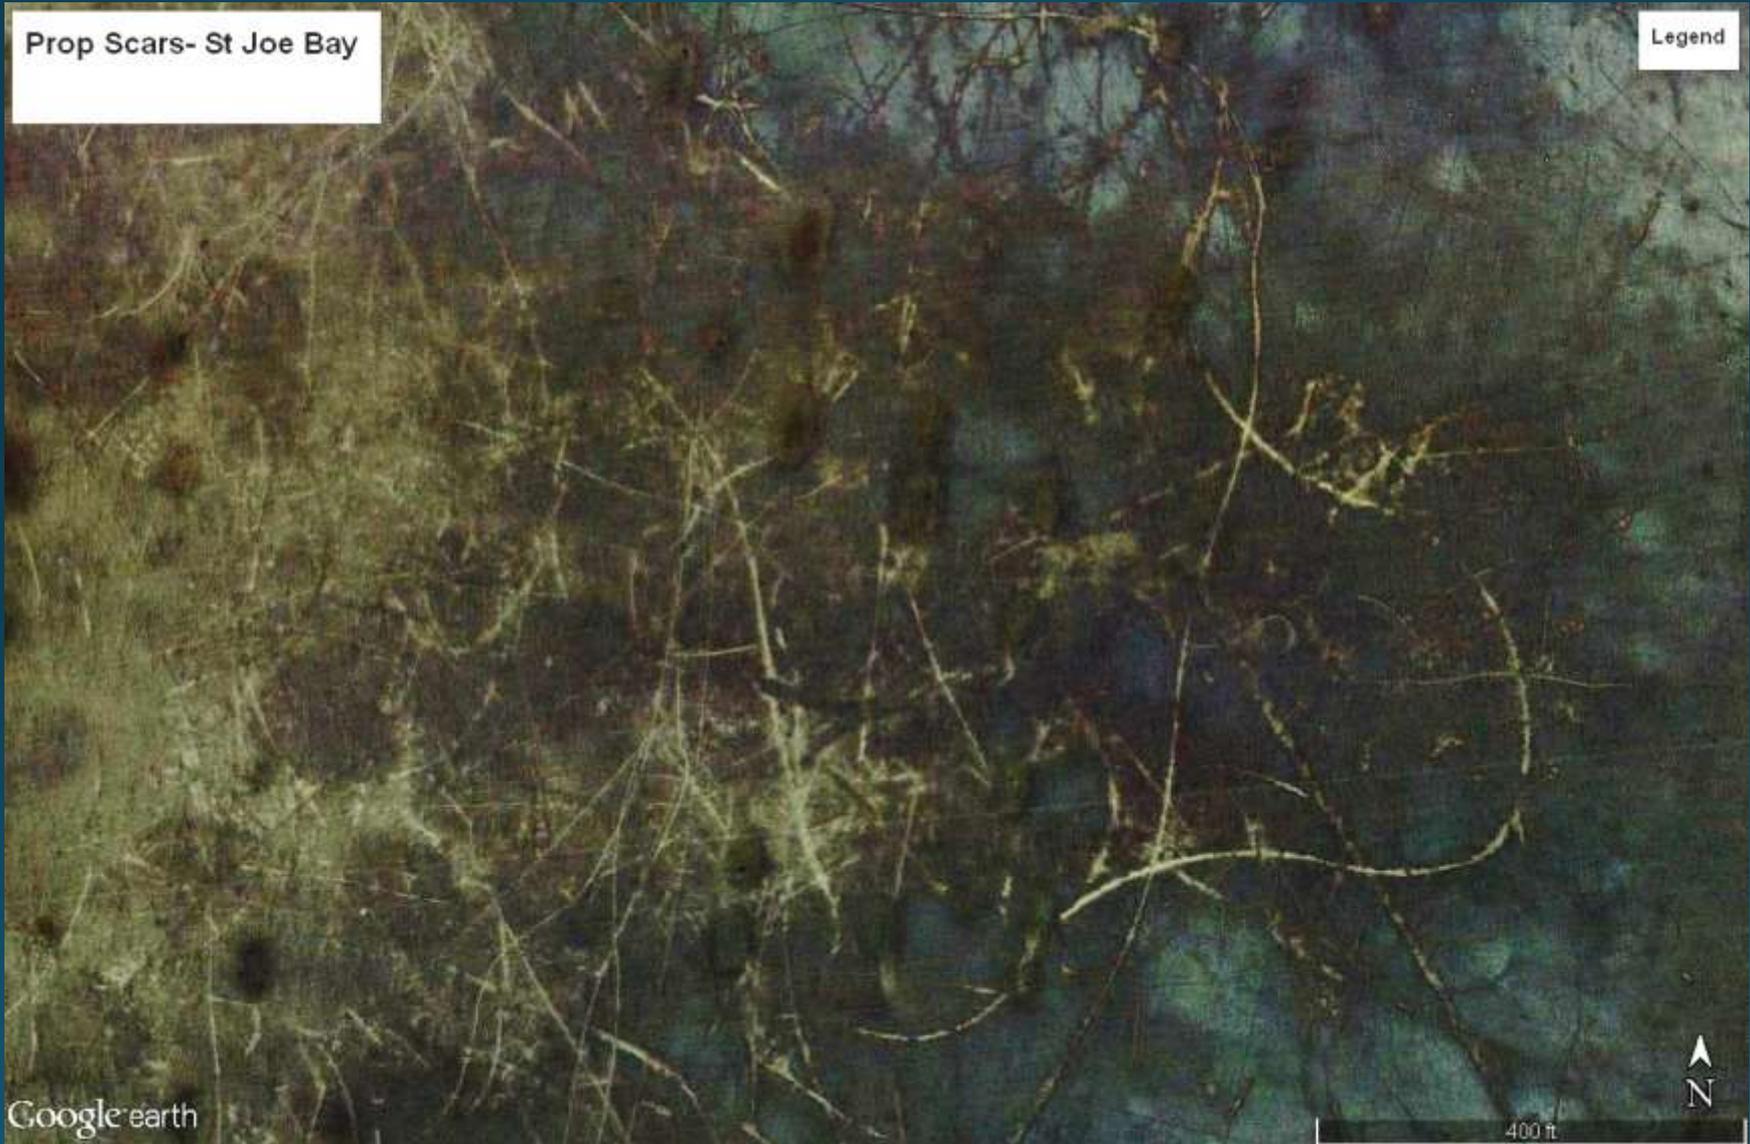
# Human Activity Impacts Include Prop Scarring

## St. Joseph Bay Propeller Scarring

Score	Description	# Cells	% of vegetated cells
9	Bare bottom visible	1056	
0	Vegetated, no scars	1998	57.3%
1	1-2 scars	646	18.5%
2	3-10 scars	466	13.4%
3	11-25 scars	265	7.6%
4	>25 scars	81	2.3%
5	Cell mostly scarred	29	0.8%
	Total scarred cells	1487	42.7%
	Total vegetated cells	3485	
	Sun Glare	248	
	Unreadable	15	
	Too Deep	2709
