Hydrology Assessment of the Guana River Wildlife Management Area

Report prepared for:
Florida Fish and Wildlife Conservation Commission

HDR Engineering, Inc.

May 2008

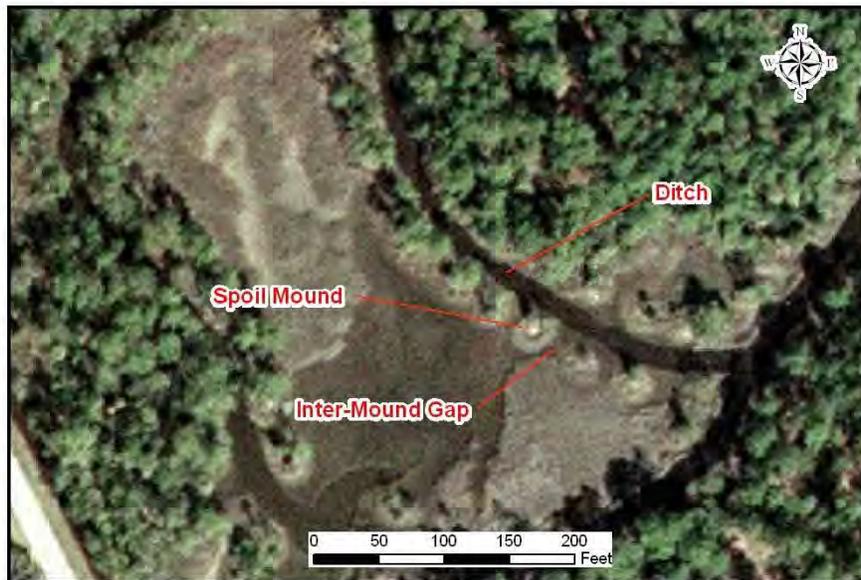
Figure 2. Example of Mosquito Ditch and Spoil Mound Configuration

Historical aerial photography indicates the mosquito ditches were excavated sometime between 1972 and 1984. They were constructed by the Palm Valley Mosquito Control District, a unit of the Anastasia Mosquito Control District (AMCD). According to a representative from AMCD, the intent was to have mosquitofish (*Gambusia affinis*) and other larvivorous fish naturally populate the ditches and when water levels overtopped the ditch banks, the fish would spill over into the adjacent wetland and feed on the larvae of the saltmarsh mosquito (*Aedes* spp.). For wider salt marshes, two ditches were created, one on either edge of the wetland (known as “rim ditching”). Occasionally, for narrow marshes, a single ditch line was deemed sufficient for mosquito control. By placing the excavated spoil such that it left gaps of undisturbed marsh between adjacent spoil mounds, the flood waters could flow largely unimpeded to the low areas where the mosquito breeding was most likely to occur (Figure 2).

In the GRWMA, rim ditching of wetlands was principally used. The ditches generally range from 8 to 18 feet in width and from less than a foot to nearly four feet in depth. Ditching created two parallel rows of circular spoil mounds or piles, one to either side of the ditch cut. These spoil mounds varied from 2 to 10 feet high with an average height of about five to six feet high. The mounds are generally about 30 feet in diameter, although some have diameters nearer to 20 feet. Because ditch maintenance was discontinued after the property was acquired by the Florida Department of Environmental Protection in

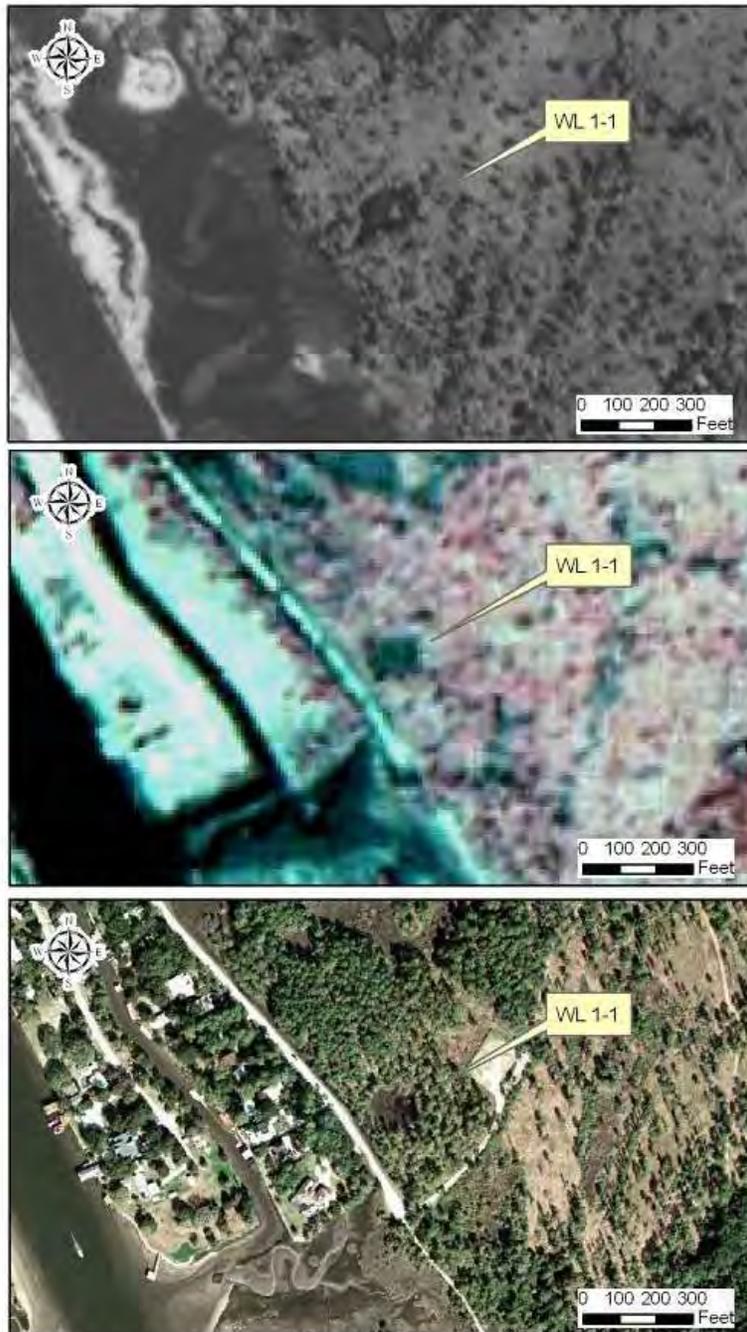
Figure 5. Wetland 1-1 on 1942 (Top), 1972 (Middle), and 2007 (Bottom) Aerial Photographs.

The wetland appears to be in good condition. Despite the deposition of spoil dredged from the Atlantic Intracoastal Waterway which was followed by the slight rerouting of surface water discharge from the wetland, the only discernable impact from ditching is a slight reduction (less than 1%) in the wetland's surface area. Site hydrology appears unaffected and no exotic, ruderal, or other invasive plant species were observed.

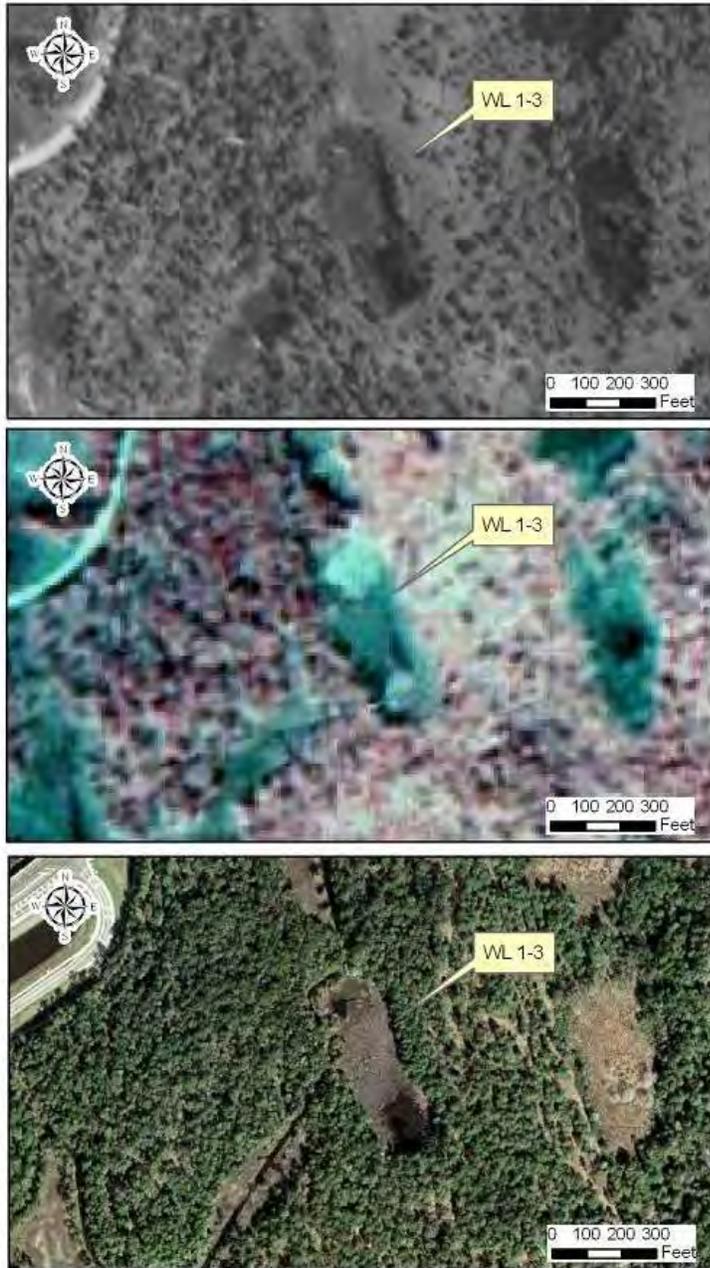
Figure 7. Wetland 1-3 on 1942 (Top), 1972 (Middle), and 2007 (Bottom) Aerial Photographs.

Comparison of the historical and current aerial photography (Figure 7) found that Wetland 1-3, except for a slight reduction in spatial extent, appears to have remained little changed over the years since 1942. Because the ditching only encroached on the northwestern periphery of the wetland, resulting in the creation of an estimated 170 ft of ditches and 12 spoil piles, only about one-quarter acre of its surface area appears to have been displaced (approximately 11% of its surface area). As indicated for the previous wetland, this impact has been offset by increased tidal circulation and improved feeding opportunities for estuarine fauna made possible by the ditching. The configuration of the ditches, spoils, and the gaps remaining between the spoils do not appear to have impeded sheet flow or changed drainage patterns. No exotic, ruderal, or other invasive plant species have invaded the ditched or unditched portions of the wetland, either in or alongside the ditches or atop the spoil mounds.

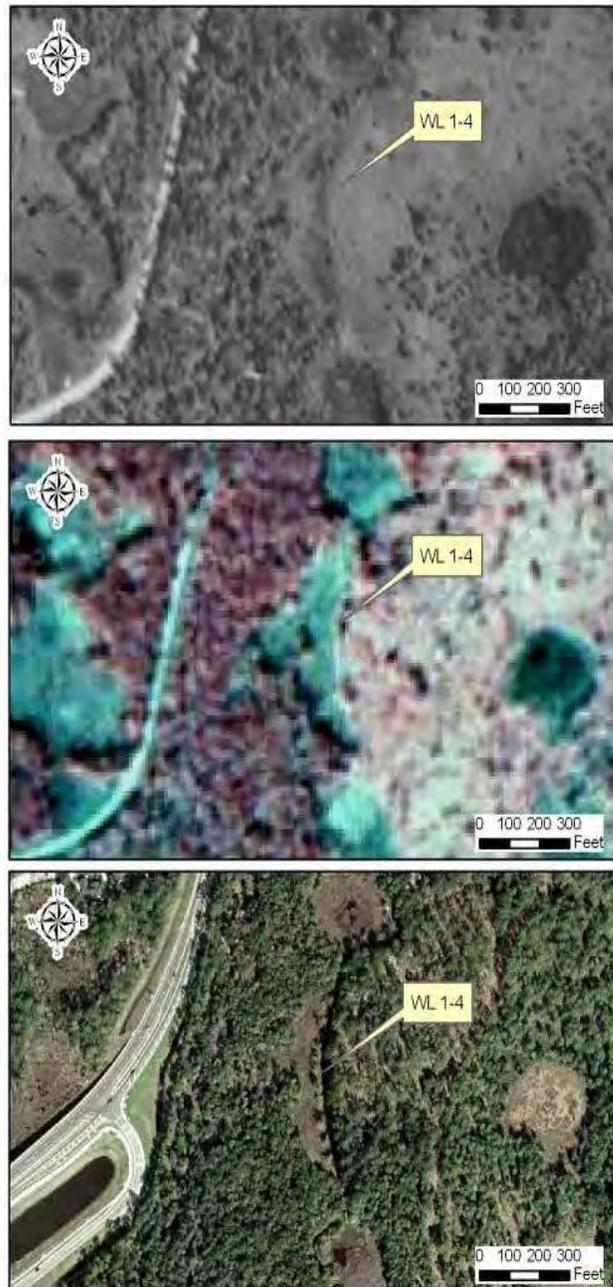
Figure 8. Wetland 1-4 on 1942 (Top), 1972 (Middle), and 2007 (Bottom) Aerial Photographs.

Wetland 1-4 experienced a sizeable reduction in surface area as a consequence of mosquito ditching (Figure 8). However, in or before 1952, a series of short, water-filled ditches or ditch-like features (mostly less than 320 feet long and up to 15-20 ft wide) traversed much of the wetland in an apparent attempt to improve drainage. Traces of these ditches are still evident on some of the later imagery. By 1984, an estimated 520-foot long mosquito ditch was constructed along the wetland's eastern periphery, flanked by two rows of 13 spoil mounds. This activity displaced slightly over a half acre (approximately 30%) of the wetland's surface area. As indicated for the previous wetland, this impact has been offset by increased tidal circulation and improved feeding opportunities for estuarine fauna made possible by the ditching. The configuration of the ditches, spoils, and the gaps remaining between the spoils do not appear to have impeded sheet flow or changed drainage patterns. No exotic, ruderal, or other invasive plant species have invaded the ditched or unditched portions of the wetland, either in or alongside the ditches or atop the spoil mounds.

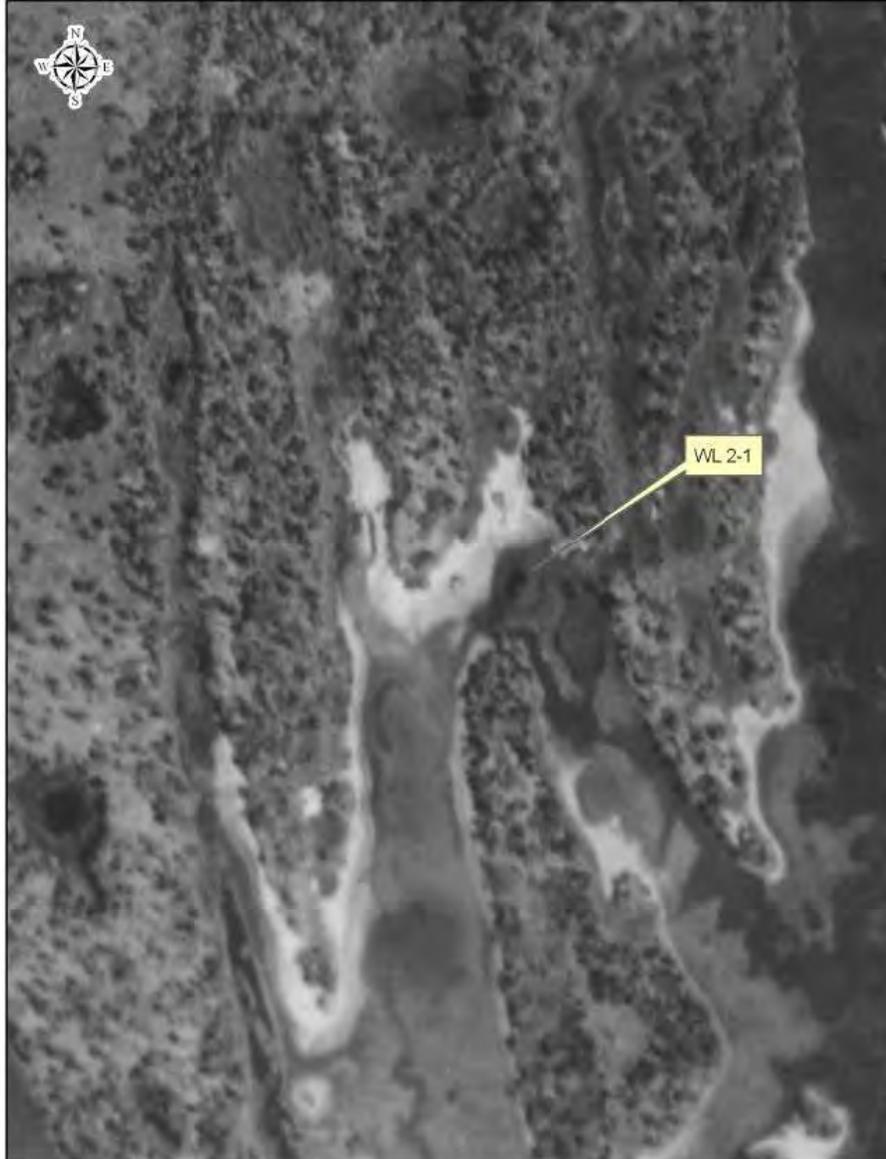
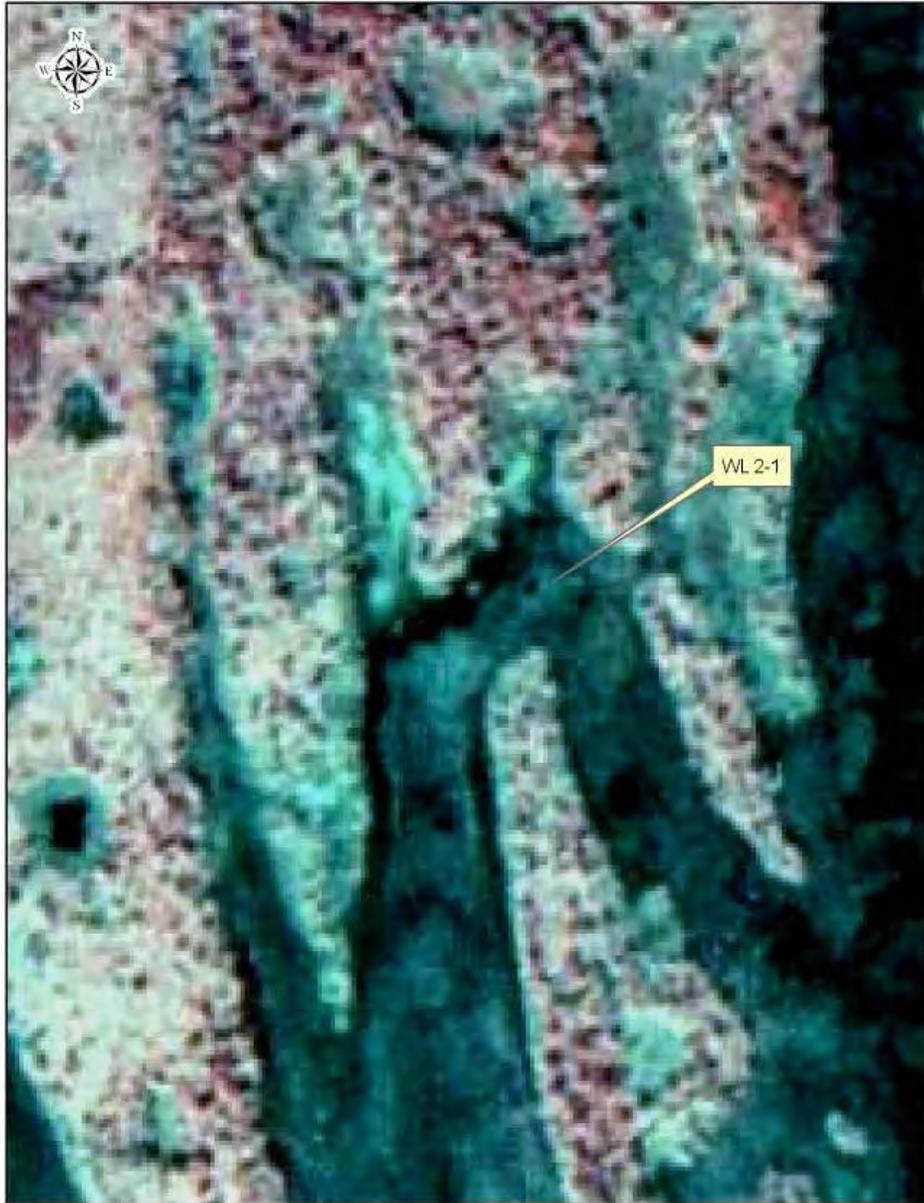
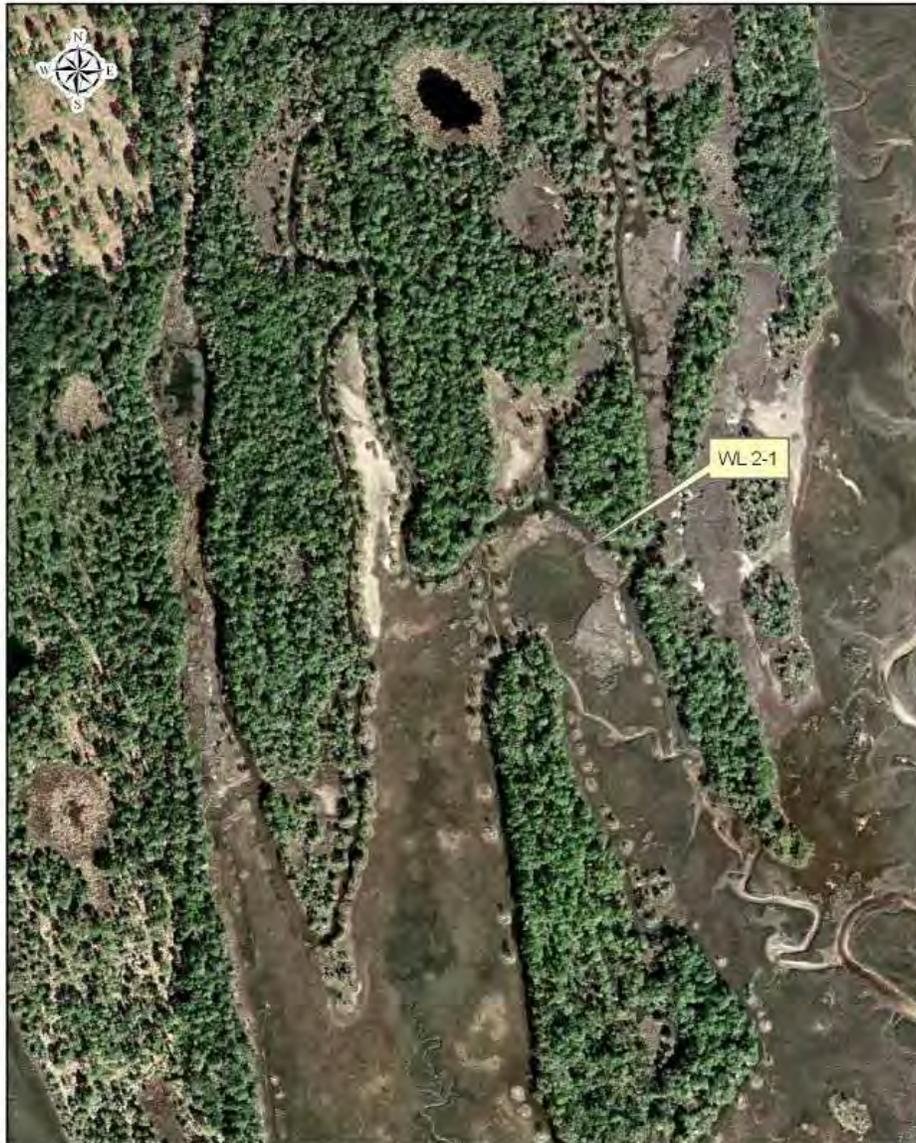
Comparison of the 1942, 1972, and 2007 aerial photography generally corroborates this assessment (Figures 10a, 10b, and 10c). The spatial extent of Wetland 2-1 and the surrounding tidal marsh do not appear to have changed discernibly during this time frame (aside from the ditches and spoils). Salterns and upland islands have also remained in their general position. No exotic, ruderal, or other invasive species are present in the ditch or on the spoil mounds. However, there has been limited displacement of tidal creek channels, in part due to their being co-opted by nearby ditch sections.

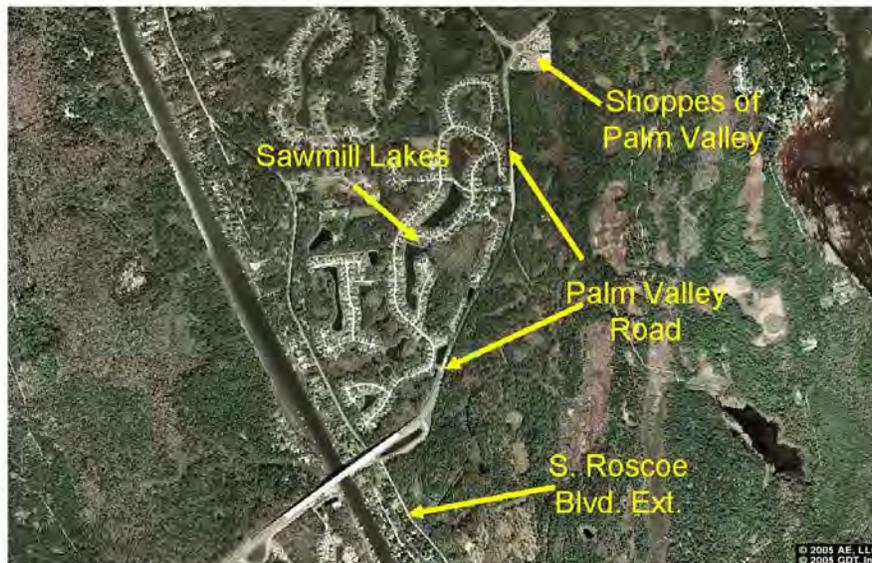
Figure 11. Development General Location Map

In general, the residential properties located along Roscoe Boulevard Extension and Canal Road drain either directly or through roadside swales to the Intracoastal Waterway. There is little or no opportunity for water from this single family residential area located along the northern entrance road to the GRWMA to contribute surface water to the GRWMA site. The general location of the developments which impact the GRWMA are shown in Figure 11.

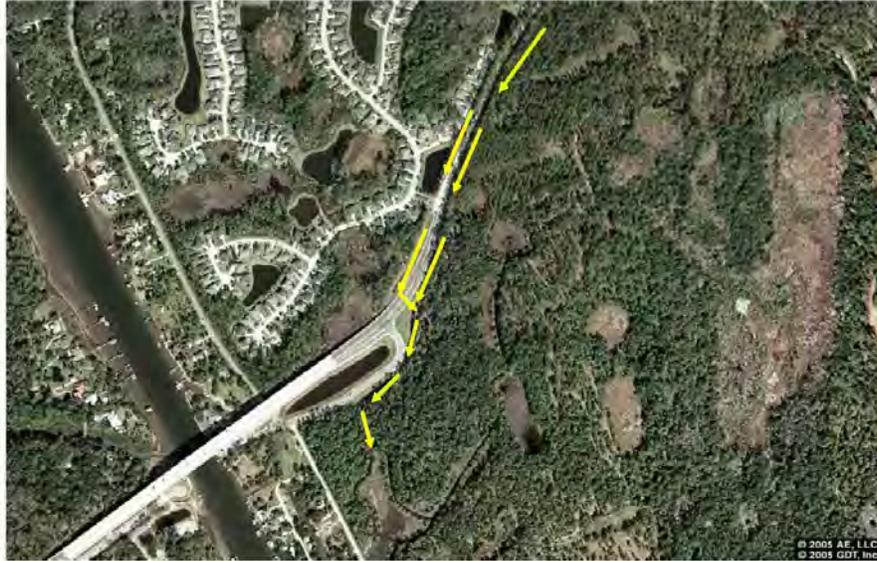
Figure 13. Generalized Palm Valley Road Drainage

The Palm Valley Road surface water management system generally consists of roadside swales and interconnecting culverts draining water from the roadway to a shallow treatment area near the intersection of the Palm Valley Road ramp with S. Roscoe Boulevard Ext. Flow from the north side of Palm Valley Road is conveyed to the south side of the road at the eastern edge of the ramp. The collected stormwater is allowed to drain into the GRWMA from the area of the ramp. Figure 13 generally depicts this drainage.

In a similar fashion, the placement and improvement of Palm Valley Road (C.R.210) has altered the drainage patterns. Prior to the roadway, sheet flow of surface water was allowed to enter the GRWMA along its northern border. The roadway drainage now captures and collects drainage and routes it to the west towards S. Roscoe Boulevard. As noted previously, this drainage is stored in roadside swale areas with a final discharge to the GRWMA at a single location near the northwest corner of the GRWMA. Thus, freshwater flow from Palm Valley Road is directed to a single entrance point into the GRWMA. This water is directed by internal ditching to the outfall near the southern end of the S. Roscoe Boulevard Extension.

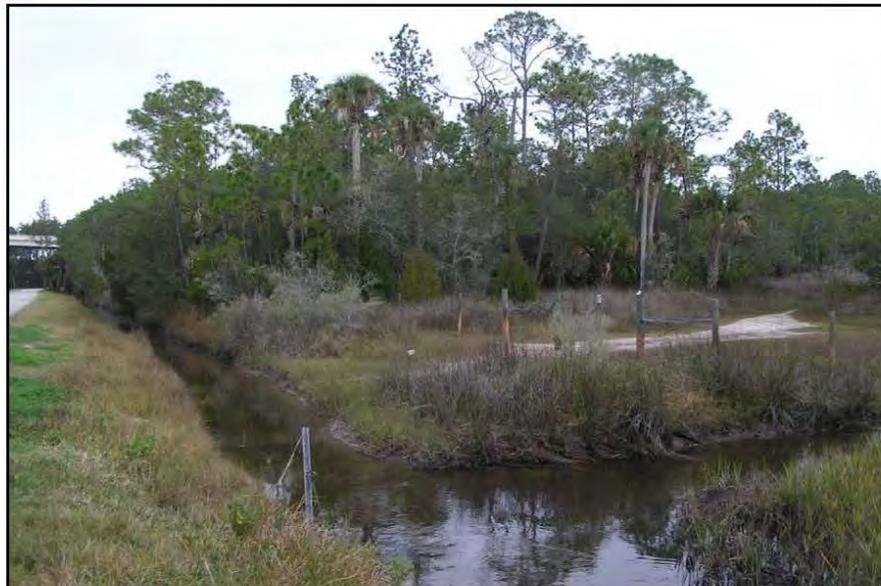
Wetland 1-2: Roscoe Blvd. South Extension east-side ditch at confluence of mosquito ditch

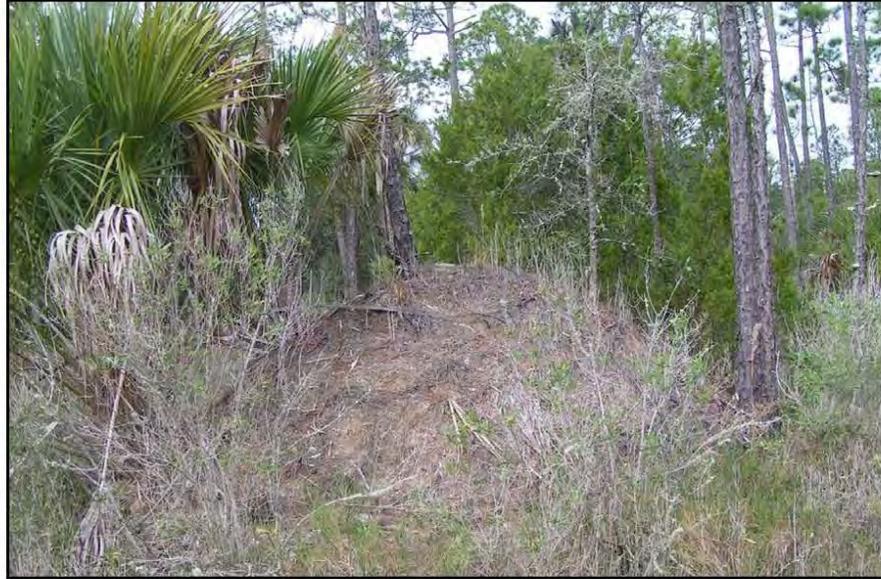
Wetland 1-2: Spoil mound

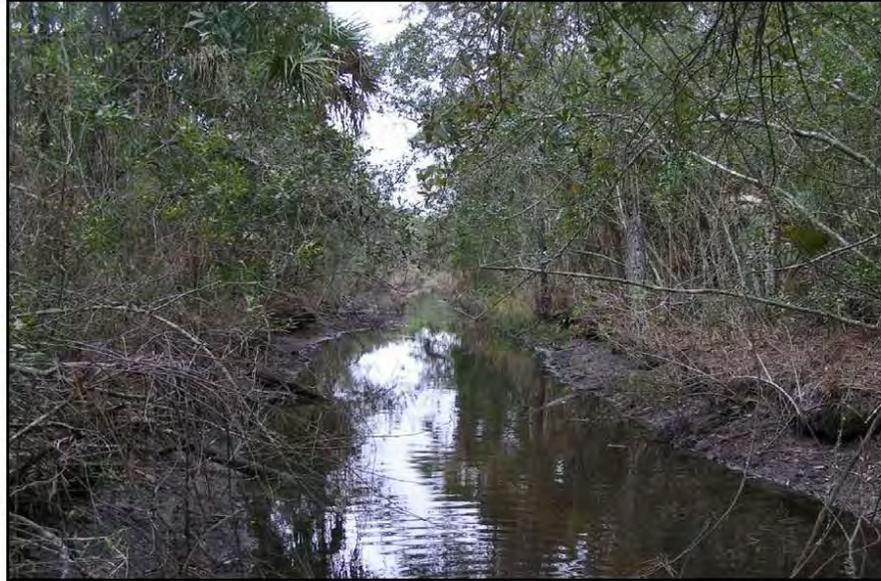
Wetland 1-3: Mosquito ditch along western edge

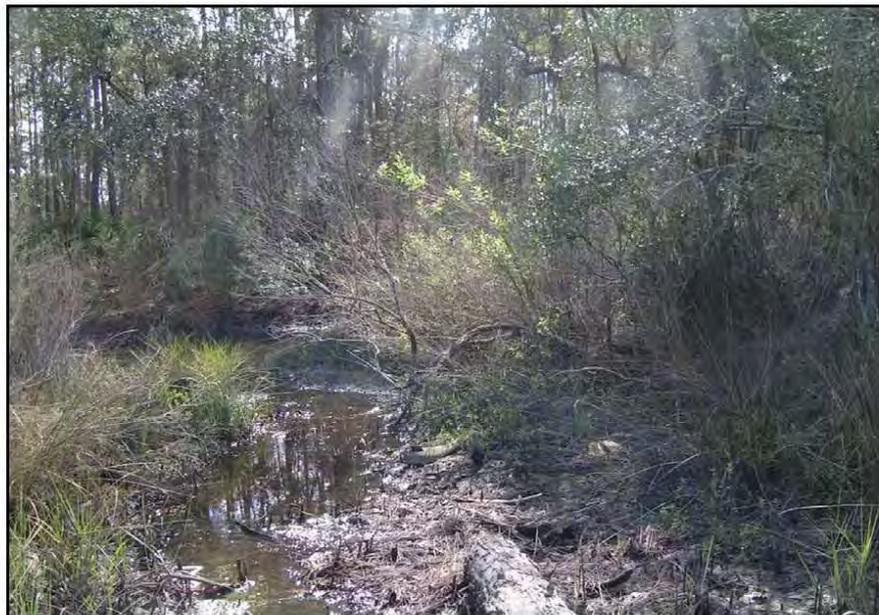
Wetland 1-5: Mosquito ditch along eastern edge

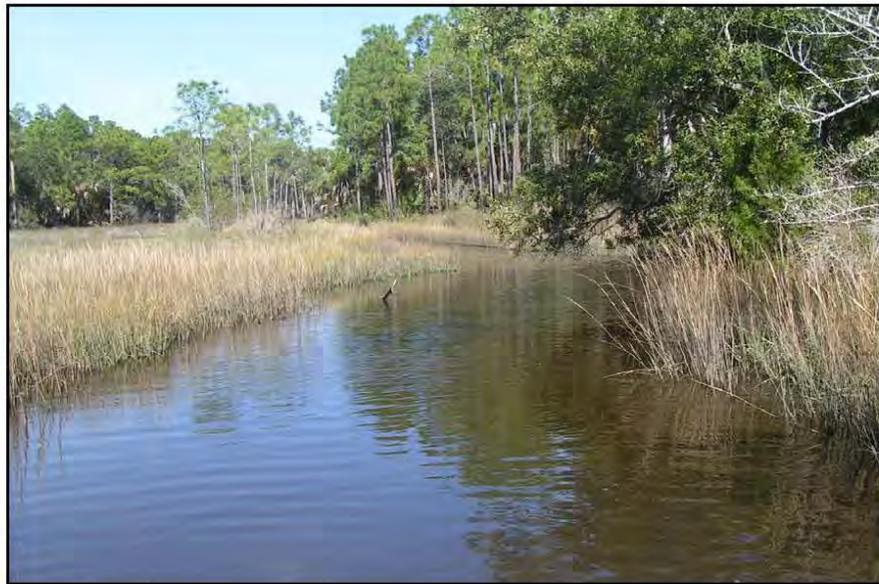
Wetland 2-1: Westernmost finger, mosquito ditch along eastern edge looking north

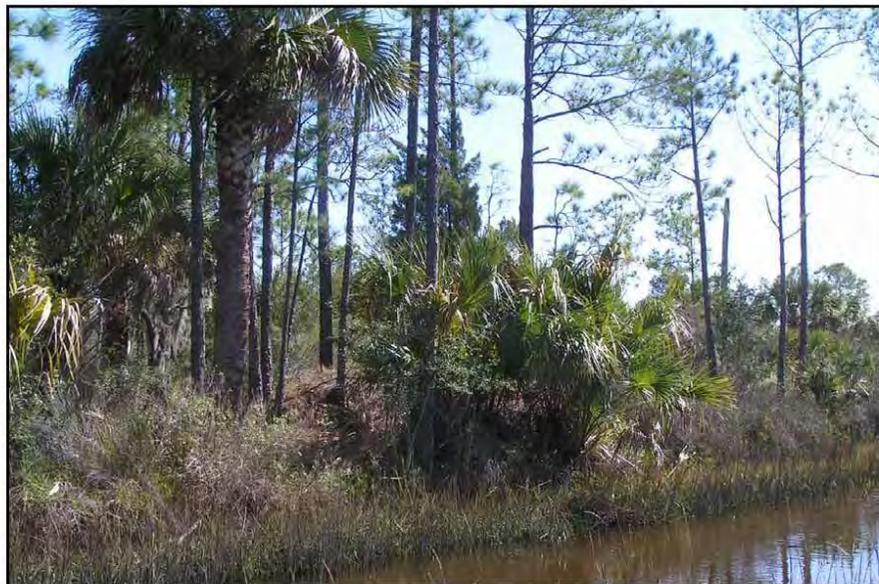
Wetland 2-1: Westernmost finger, mosquito ditch and spoil mound along eastern edge

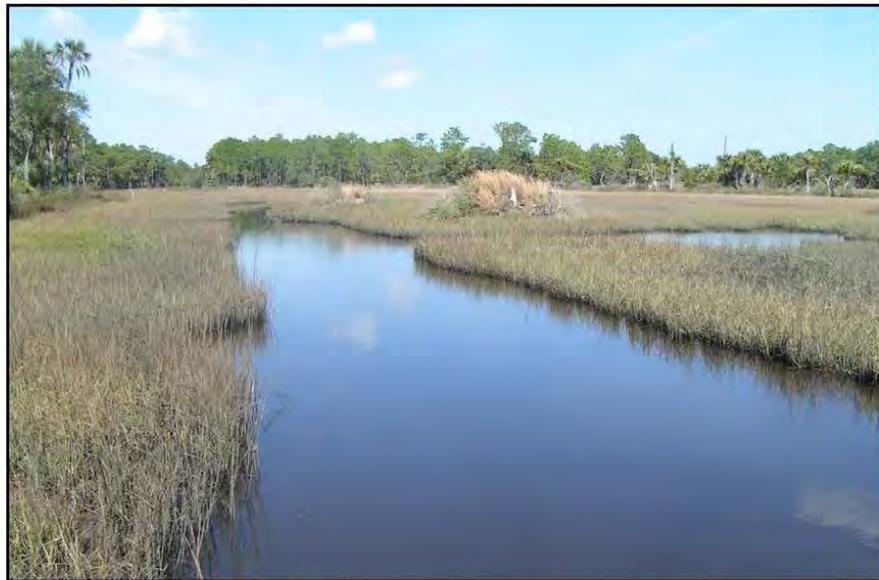
Wetland 2-1: Westernmost finger, mosquito ditch along western edge looking north

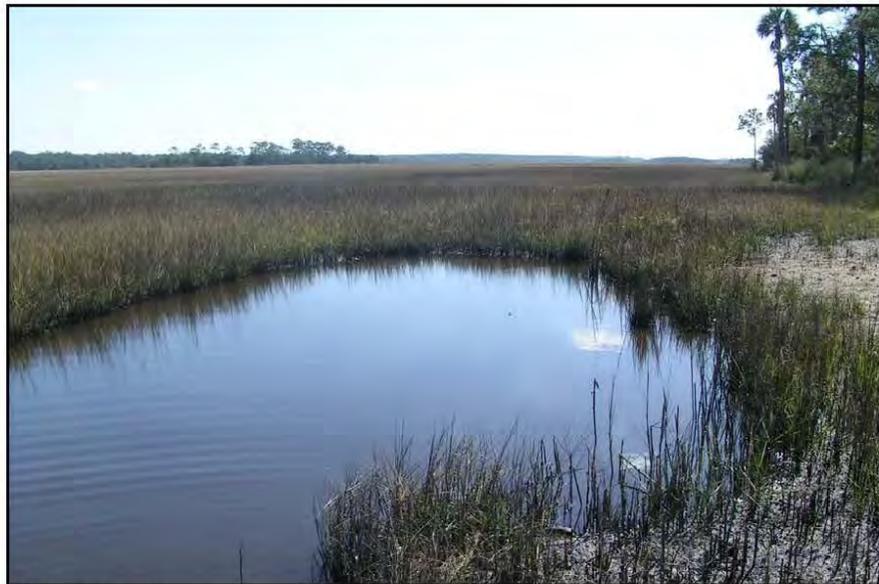
Wetland 2-1: Westernmost finger, mosquito ditch along western edge looking south
