Florida Fish and Wildlife Conservation Commission Meeting

Moving Water to Florida Bay

July 11, 2017

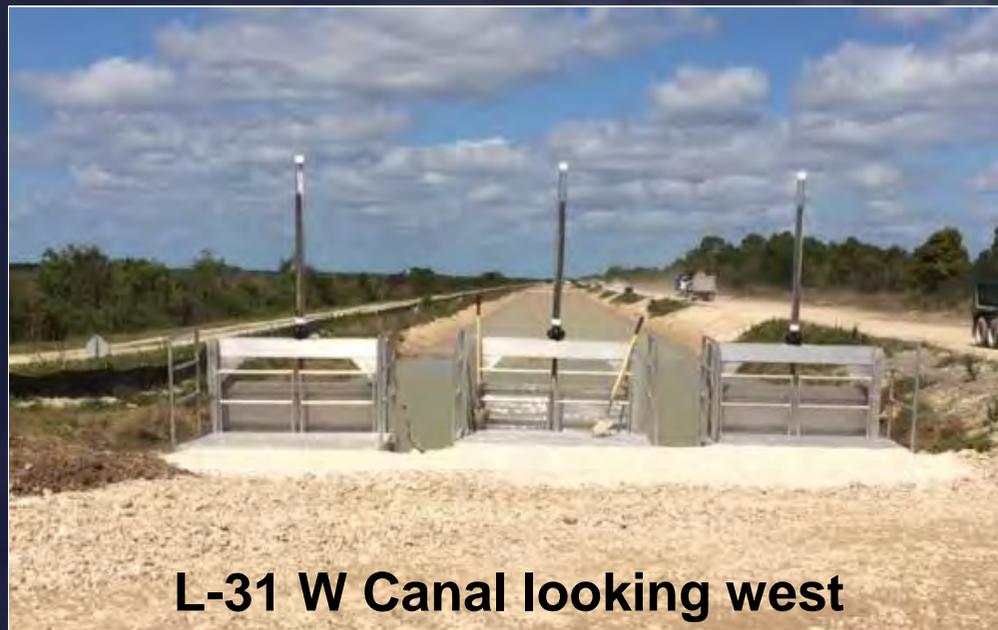
L-31 W Canal looking west

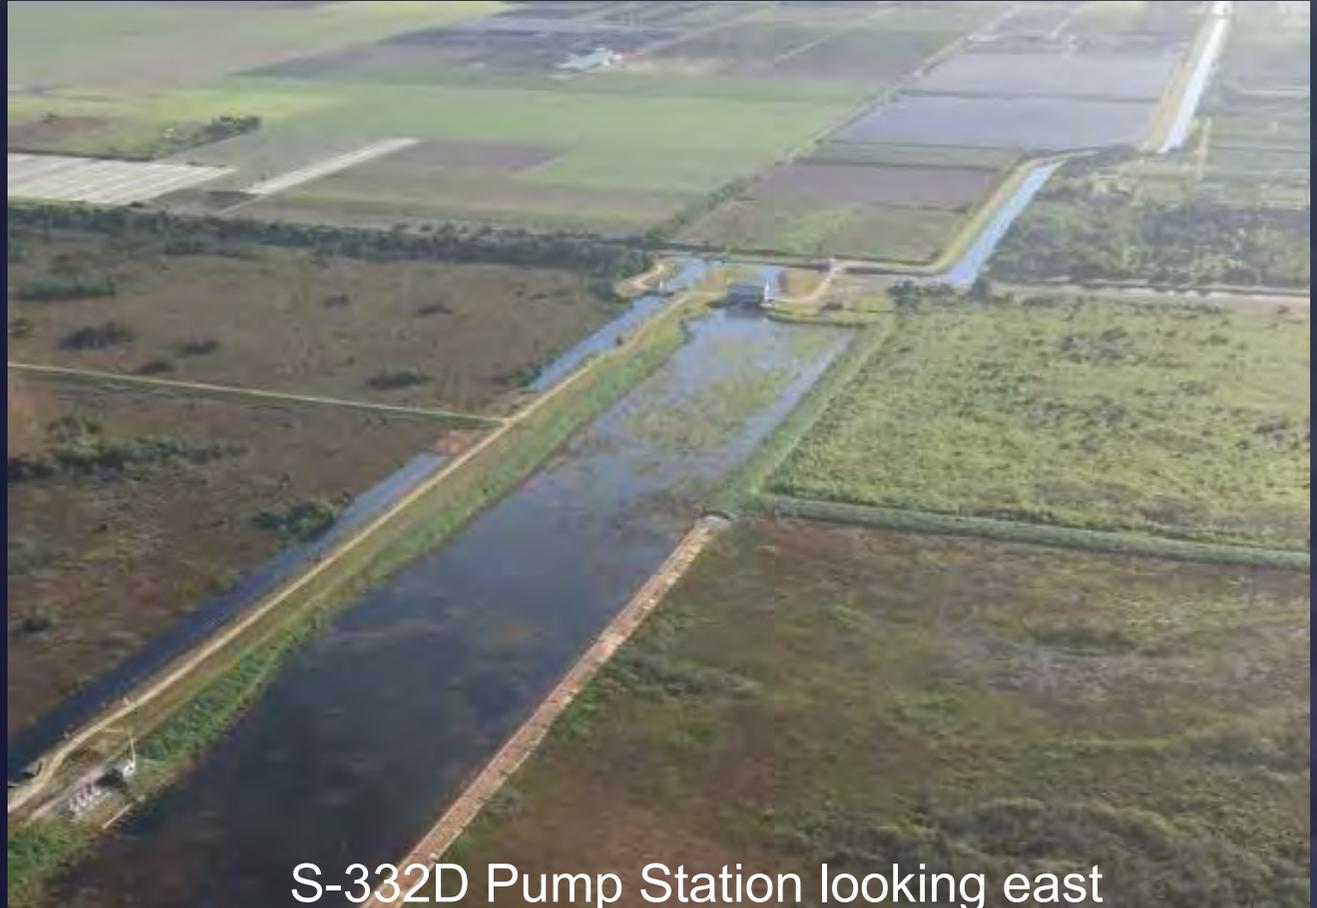
S-332D Pump Station looking east

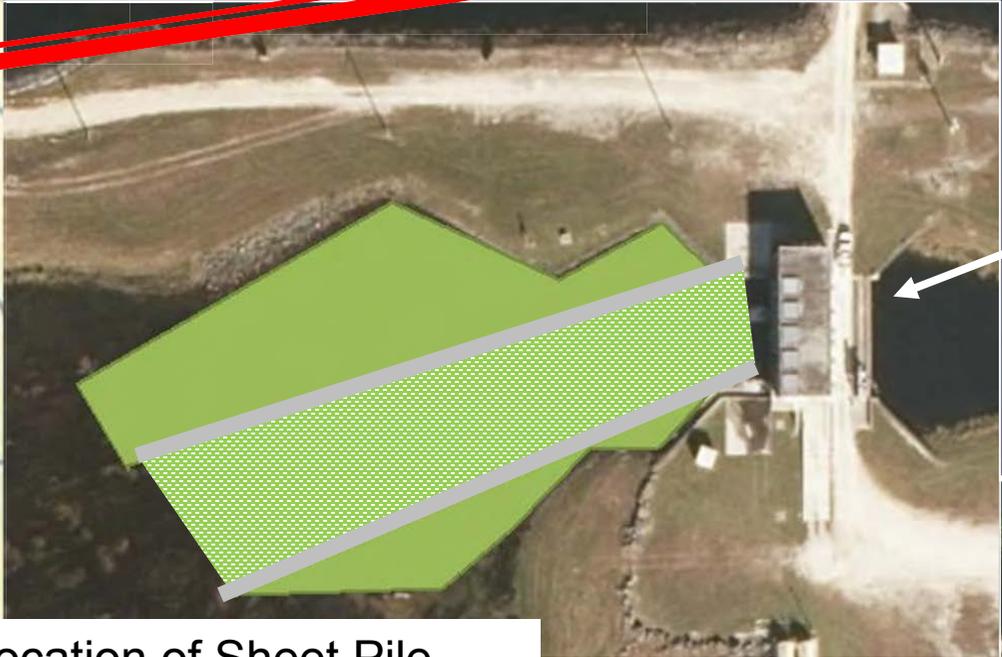
S-332D

Location of Sheet Pile and Tremie Concrete to Seal Discharge Basin

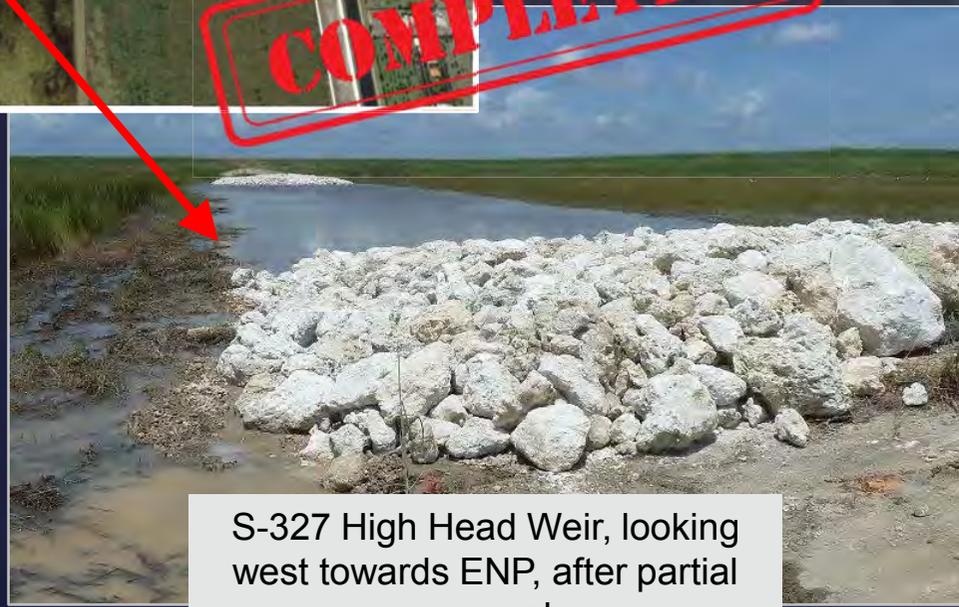
S-327 High Head Weir, looking west towards ENP, after partial removal

Modify S-332D High Head Cell Weir

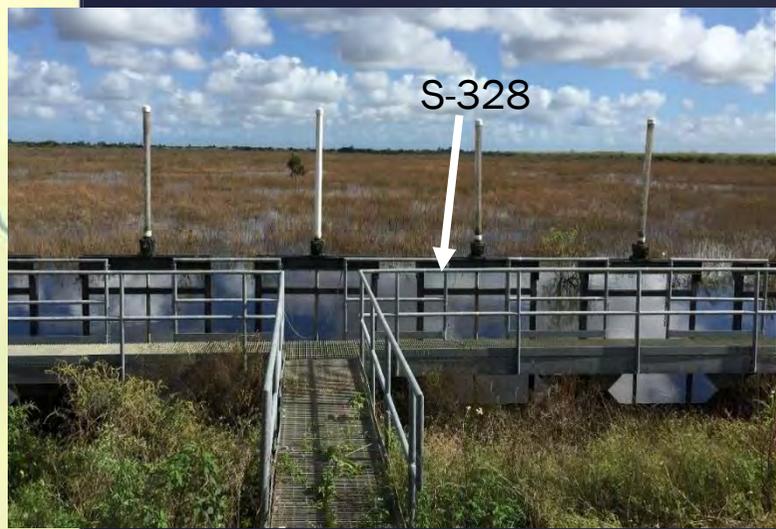
Looking east - S-332D Flowway

Operate S-328 to Deliver Water to Taylor Slough

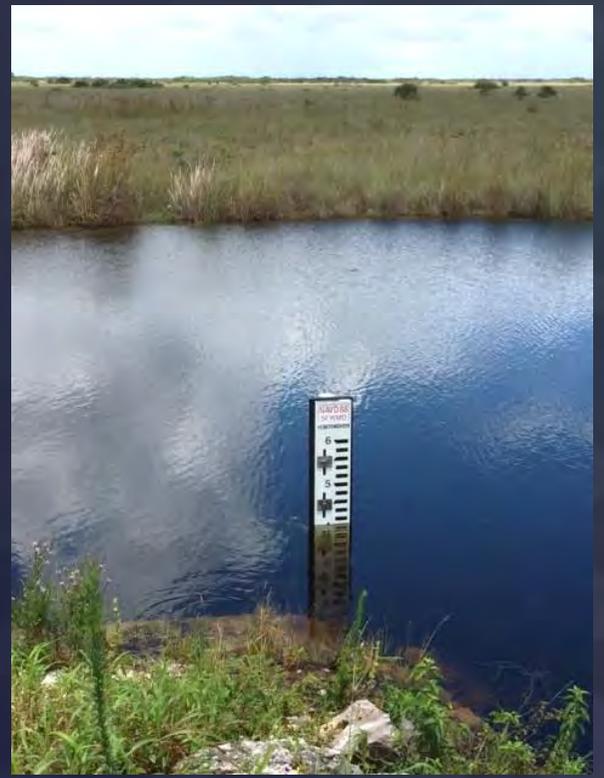
Looking west from L-31W Canal towards ENP

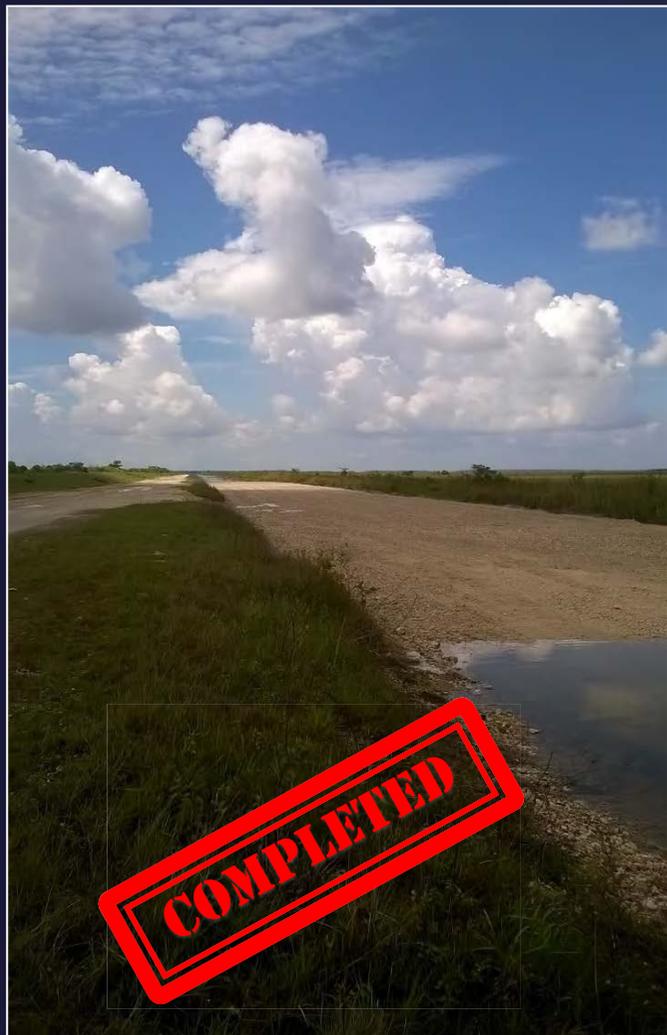
Plug F Looking South
100% Complete

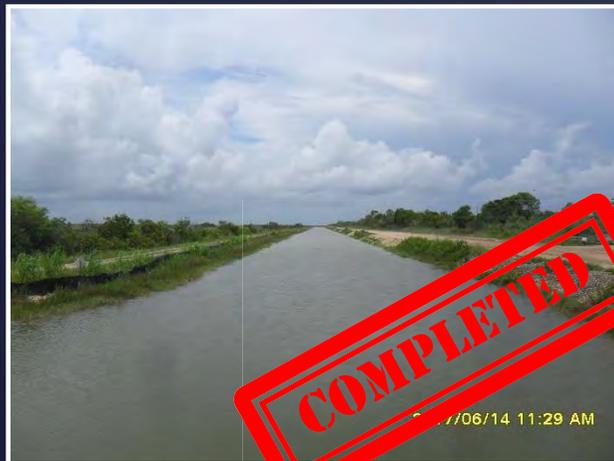
Plug G Looking West (submerged)

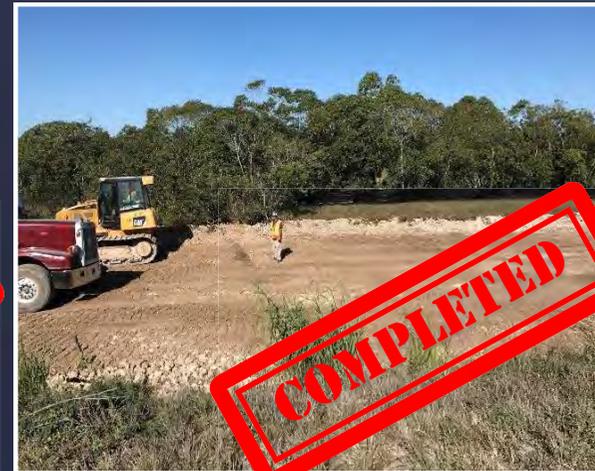
Plug H Looking West

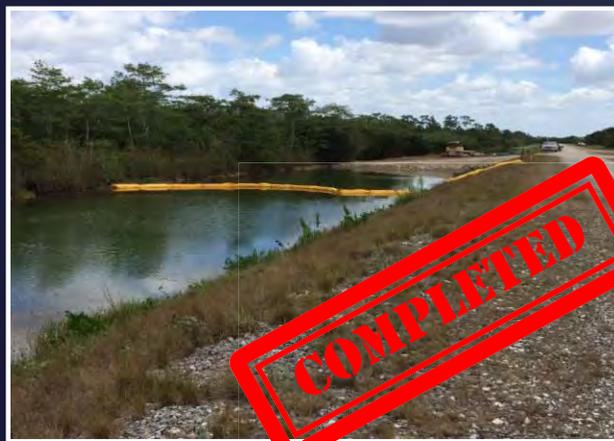
Plug J Looking North
100% Complete

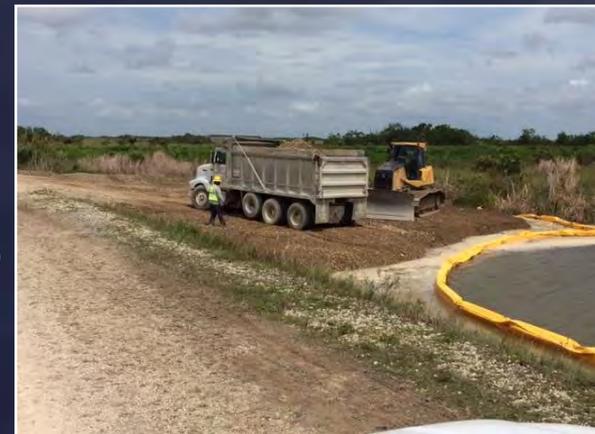
Plug A Looking Northwest
30% Complete

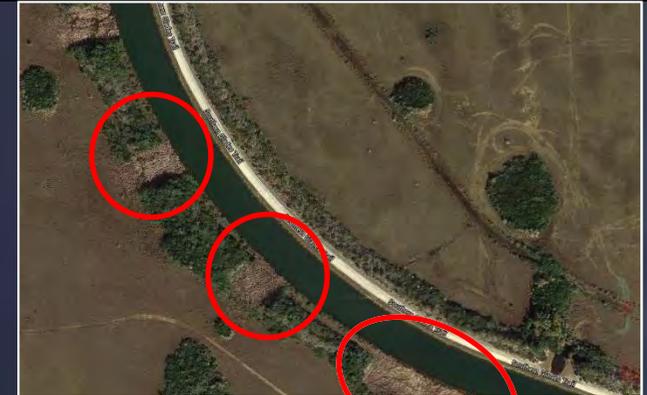
Vegetation clearing south of S-18C

- ✓ Remove vegetation along C-111 Canal south of S-18C
- ✓ Remove or cut roads within Aerojet facility
- ✓ Mechanical clearing of vegetation in S-200 and S-199 header channels
- ✓ Mechanical clearing of vegetation in S-357 Flowway
- ✓ Controlled Burn at Frog Pond Detention Area

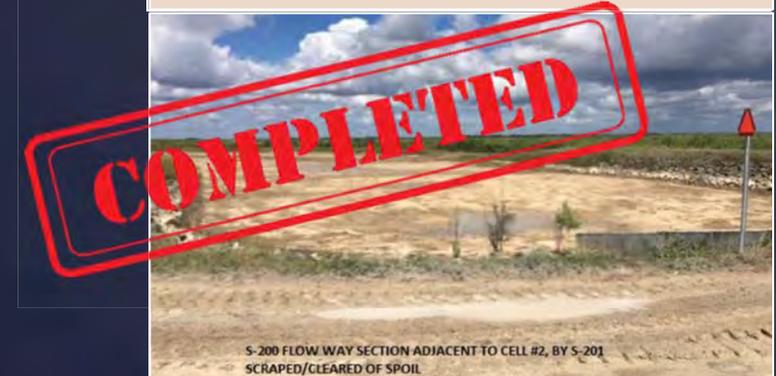
Mechanical clearing of S-200 Channel

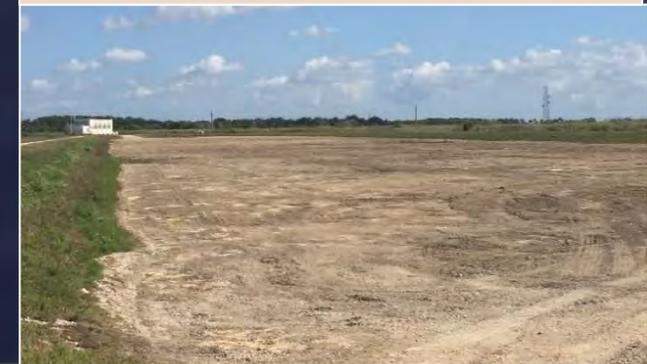
Mechanical clearing of S-357 Flowway

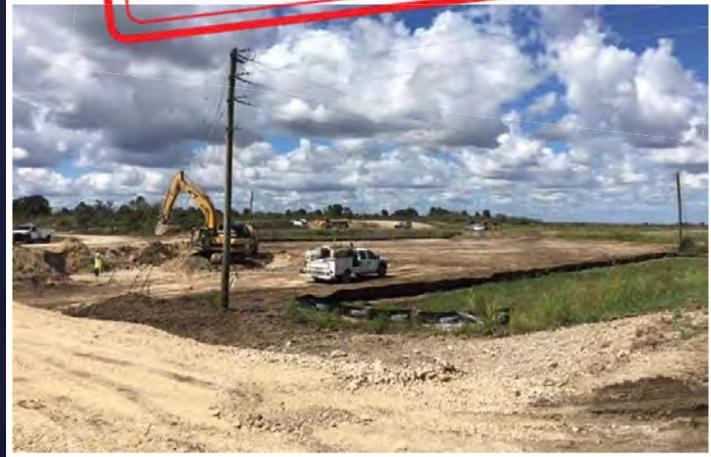
Scraping to Cap Rock and Excavating Sump Area

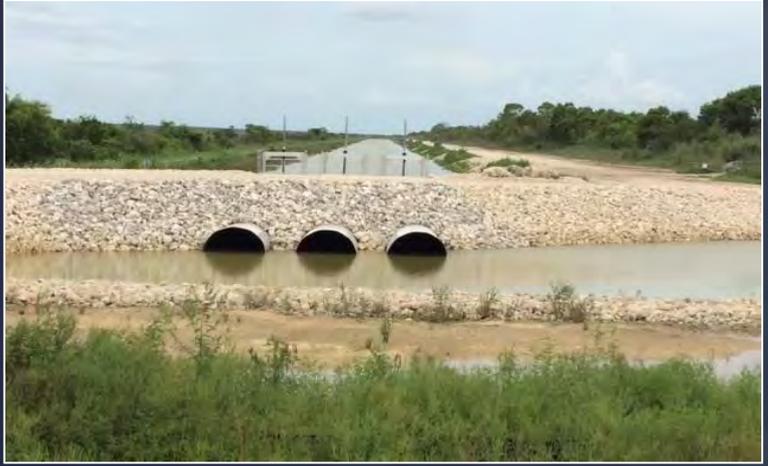
G-737 Intake

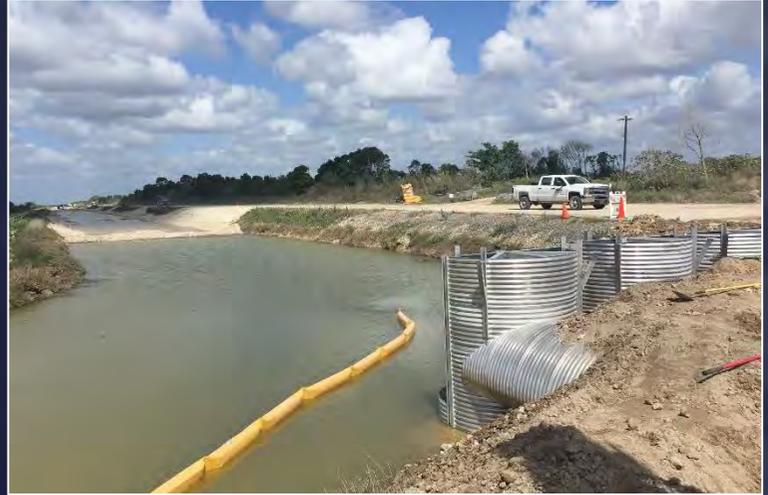
Culverts from C-200 to L-31W Canal/
L-31W Canal Plug G
