# Roadblocks to Seagrass Recovery: Seagrass Restoration Planning

Panama City, February 12, 2016

1. Identify obstacles to seagrass recovery and expansion in target estuaries
2. Develop a GIS Seagrass Recovery Potential (SRP) model of potential stressors and obstacles to recovery and spread in each estuary
3. Use SRP model to identify candidate areas, methods, tools, and projects for successful seagrass recovery and enhancement.

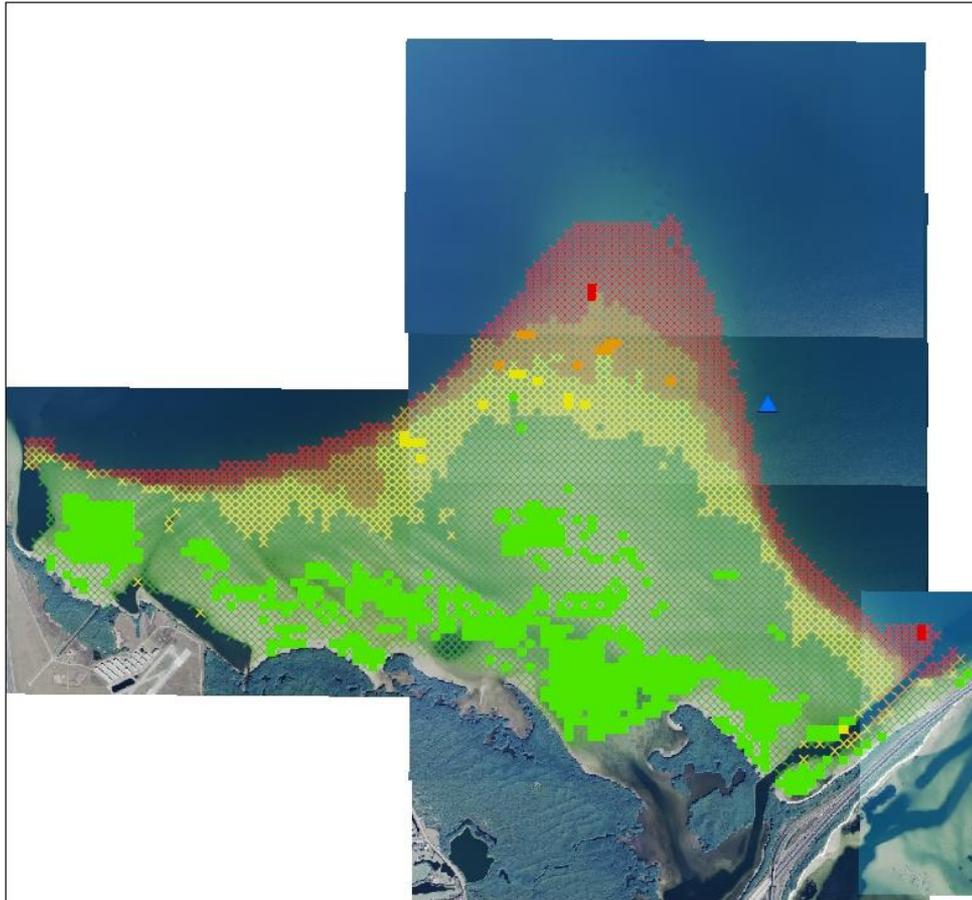
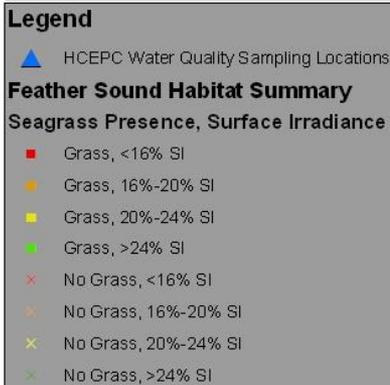
# Example of Grid-Based Modeling Approach- Feather Sound, Tampa Bay

## Inputs:

- HCEPC Water Quality Data
- Bathymetry Data
- Seagrass aerial photos

Process: Use OWQ data to calculate transparency and bathymetry to calculate light availability (%SI).

Result- Critical assessment of minimum light requirement for Shoalgrass- *Halodule wrightii*

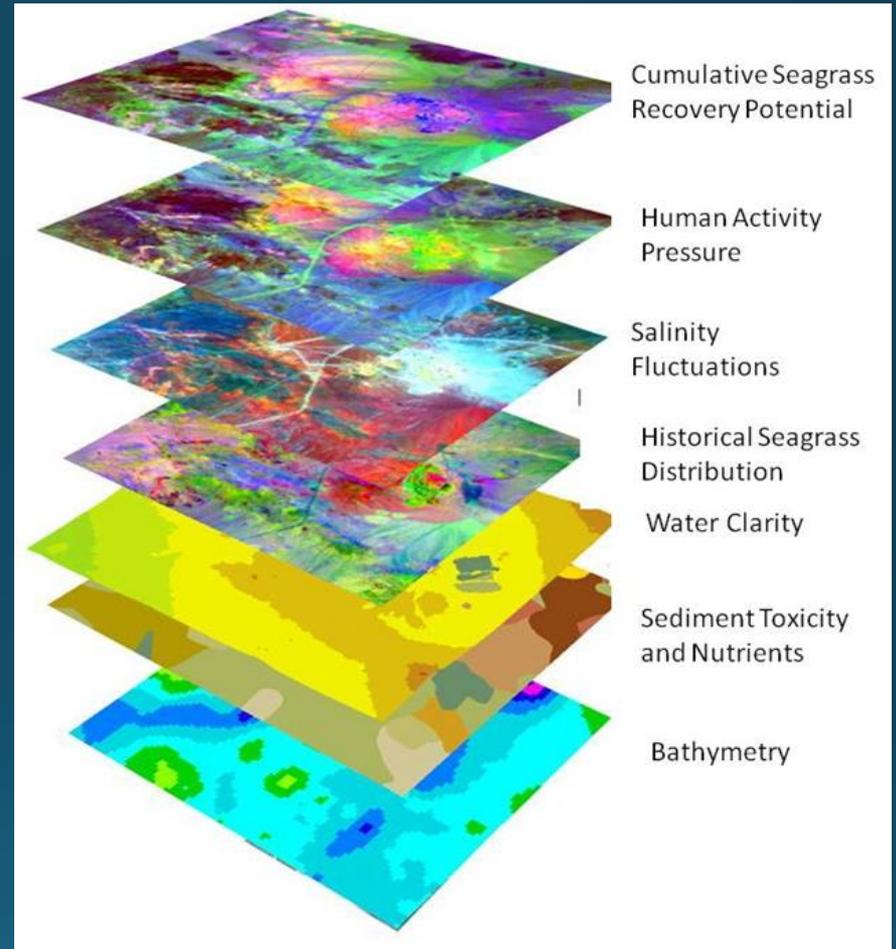
## Model Layers- Partial List

Current seagrass distribution  
Historical seagrass distribution

Bathymetry

In Situ Optical Water Quality  
MODIS Optical Water Quality

Sediment Toxicity

Physical Disturbance

Animal Disturbance

Salinity Fluctuations

Hypoxia and Anoxia

Human Activity Pressure

Platform- ArcGIS

Products- Shapefiles and KML

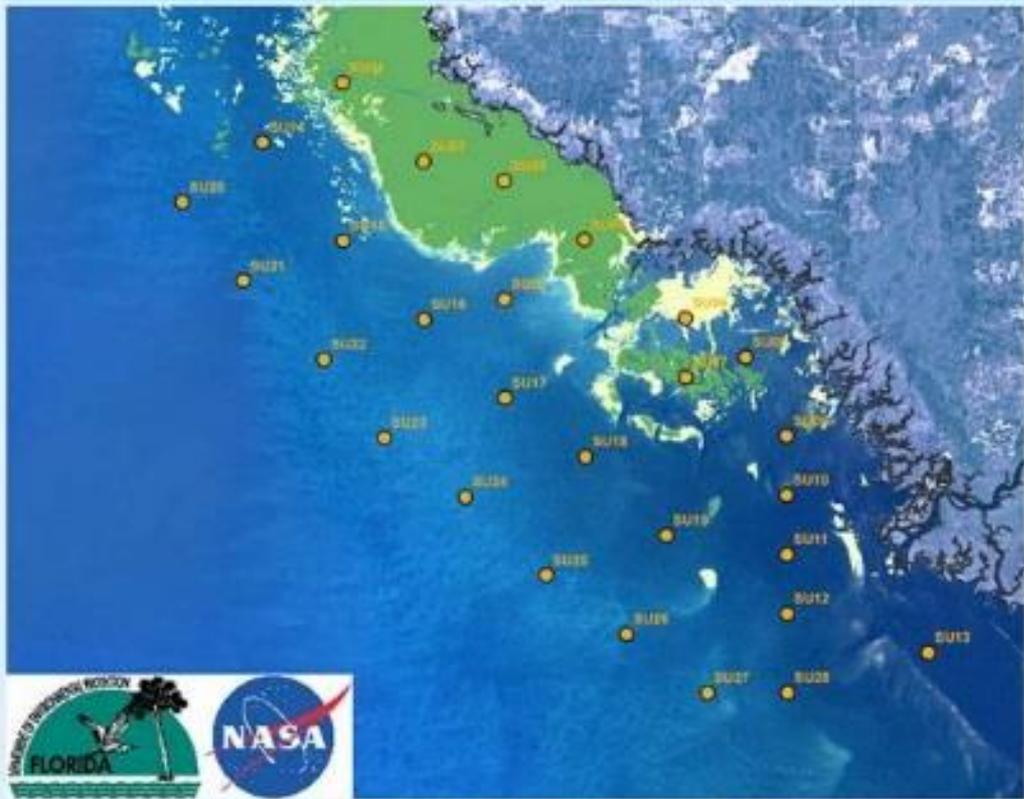
Suwannee Station Clickable Map

By clicking on any of the stations on the image to the right, you will be taken to the data for that station. These links can also be found in the menu to the left under the Projects section. If you are looking for the Steinhatchee Big Bend Region page you can click here:

Click on any of the stations above to see the data.

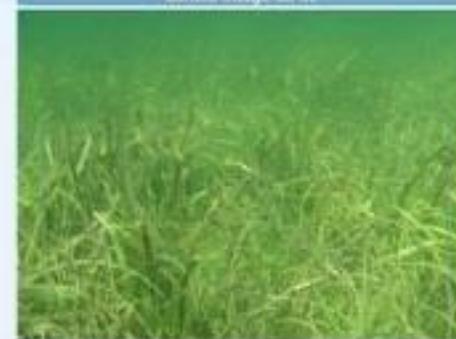
Bottom Image SU 02

This is an image representative of the bottom of Station SU 02. It is described as "DCCOP" which is explained to the left in the "Bottom Type" Section. Click on the image to open a larger image.

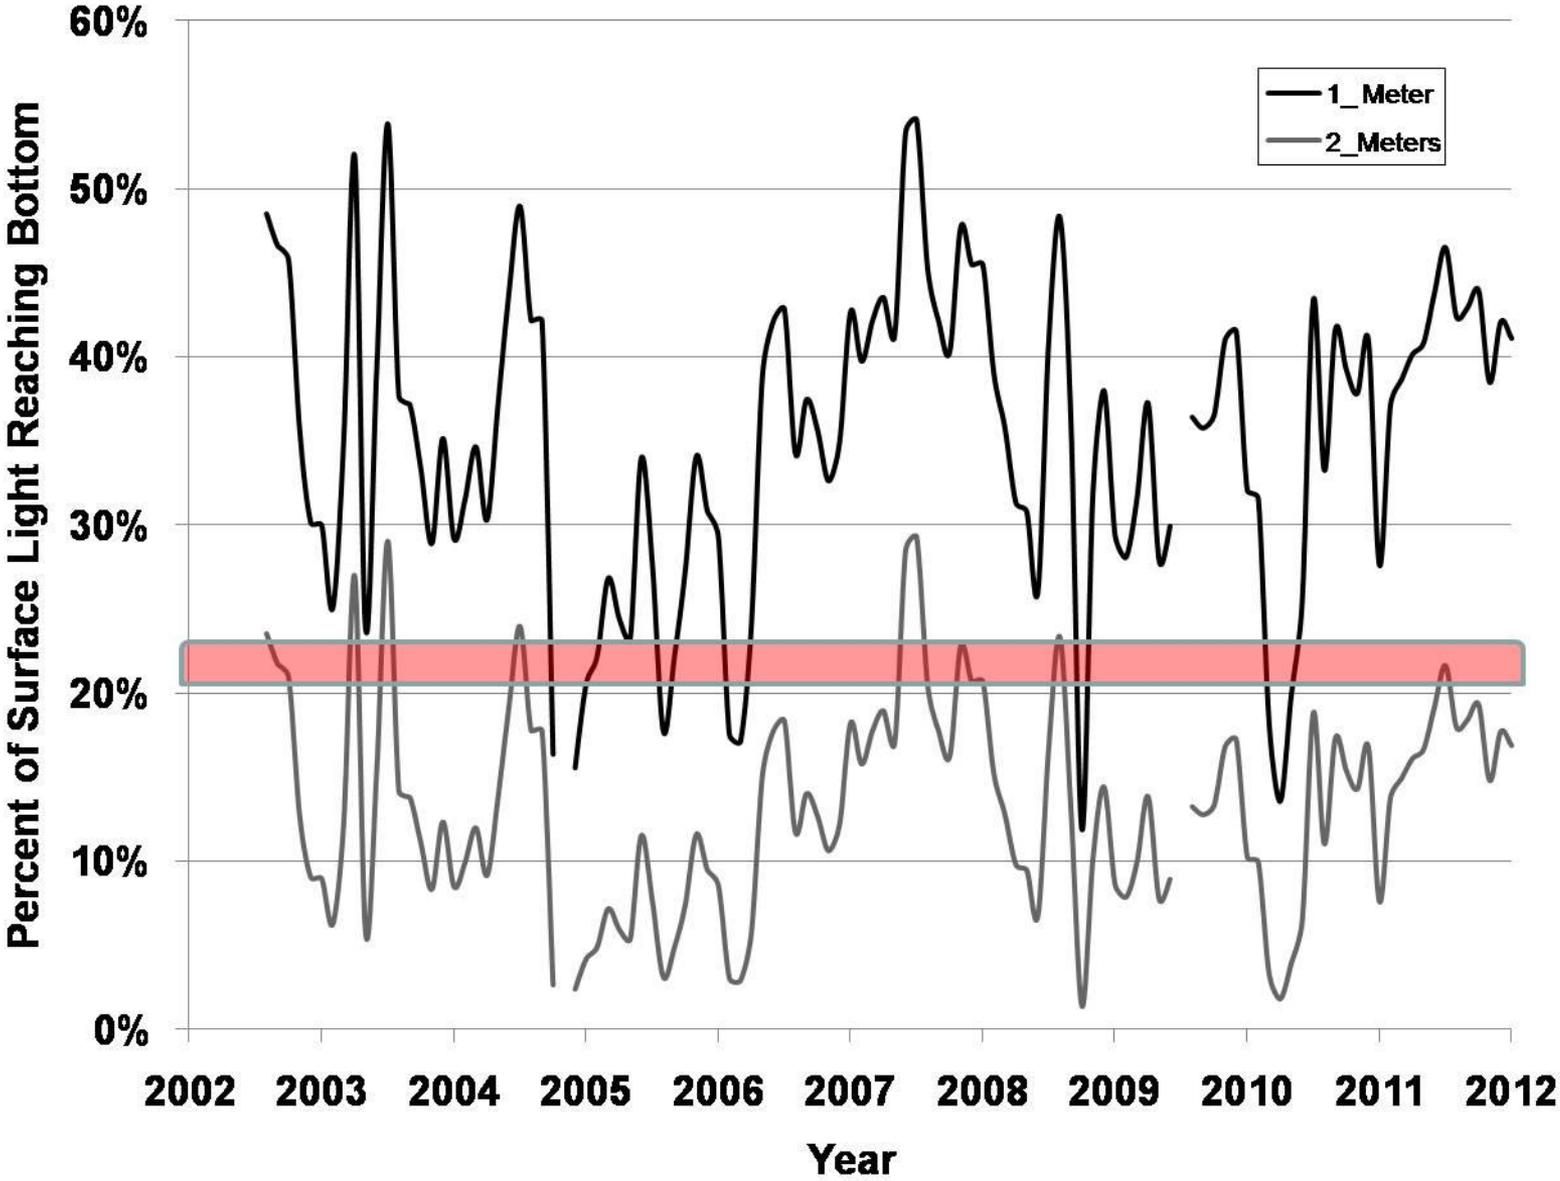
# Light Penetration in Water Column

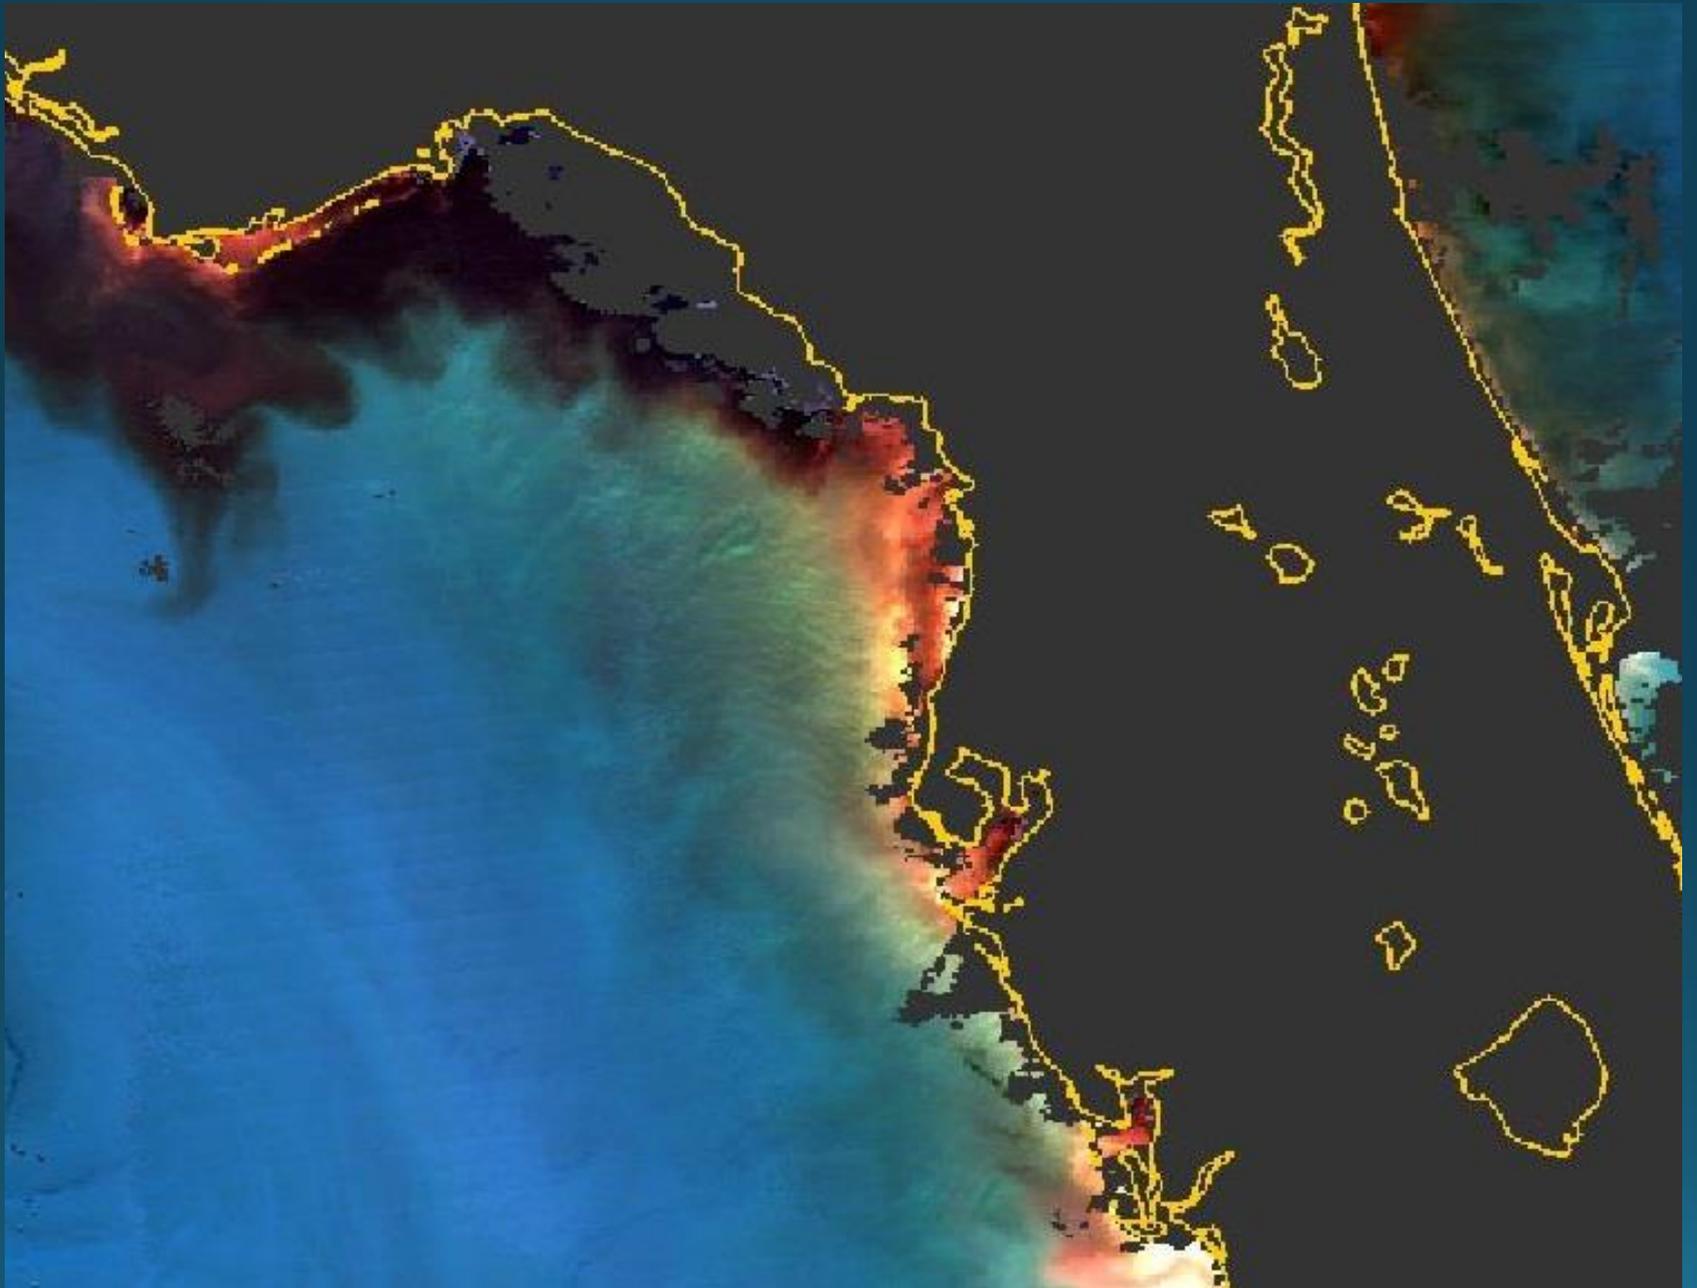
# MODIS Image- CDOM from Suwannee and Ochlockonee Rivers

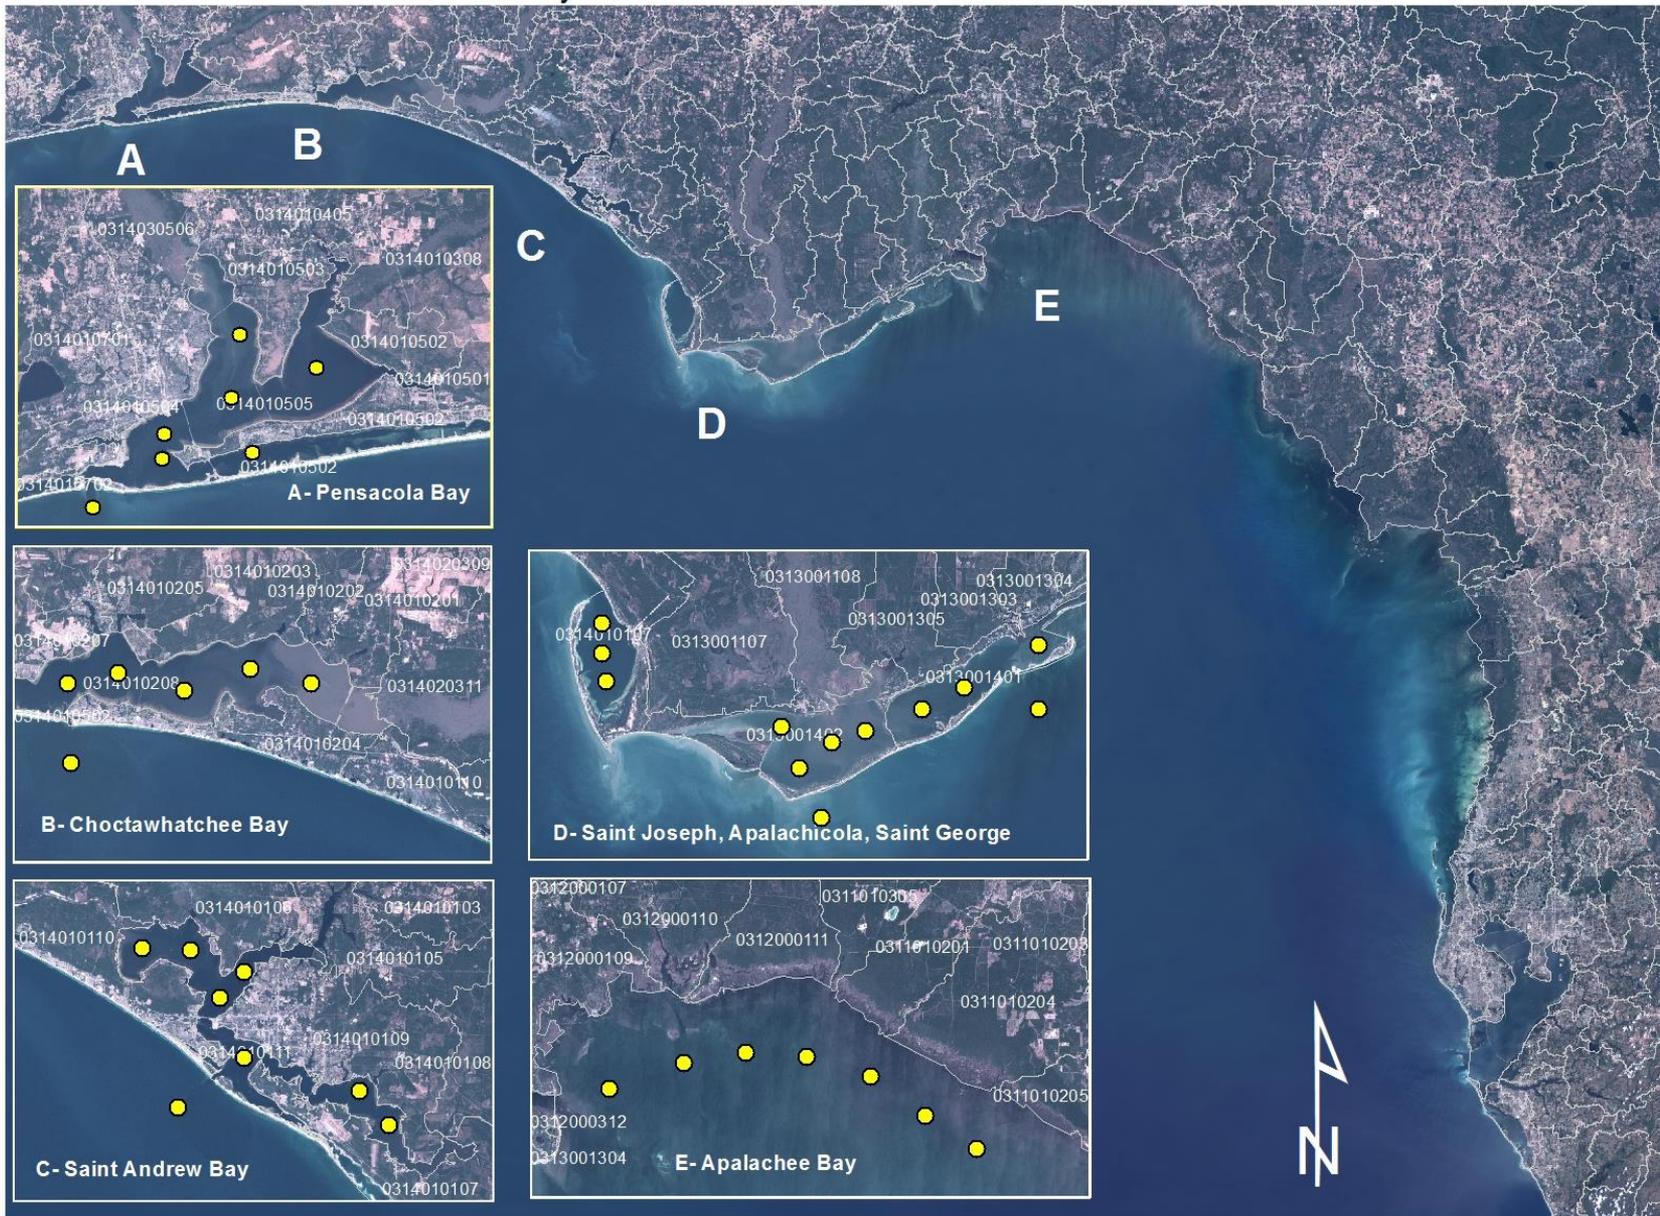
# Virtual Buoy Stations for Florida Panhandle Estuaries

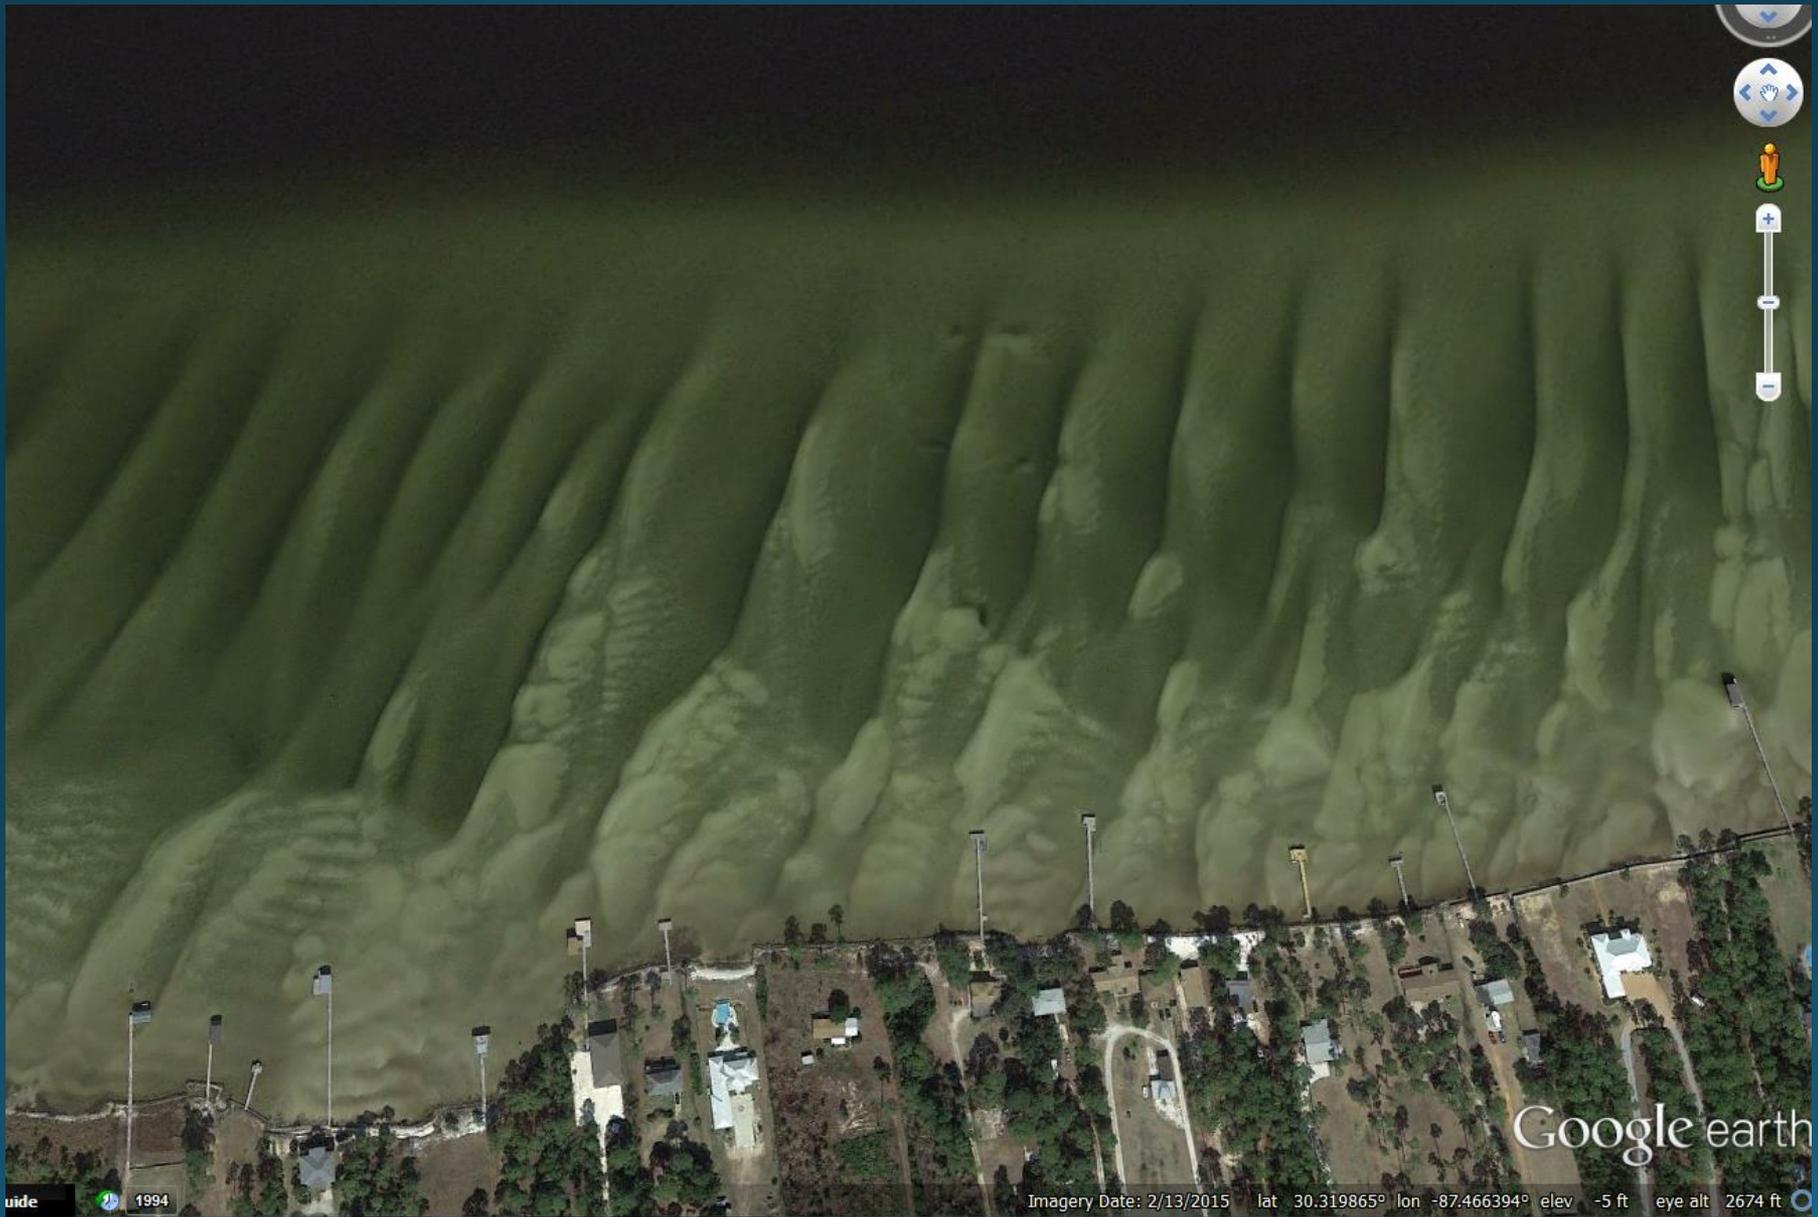
# Physical Disturbance Suggested by Sediment Bed Form

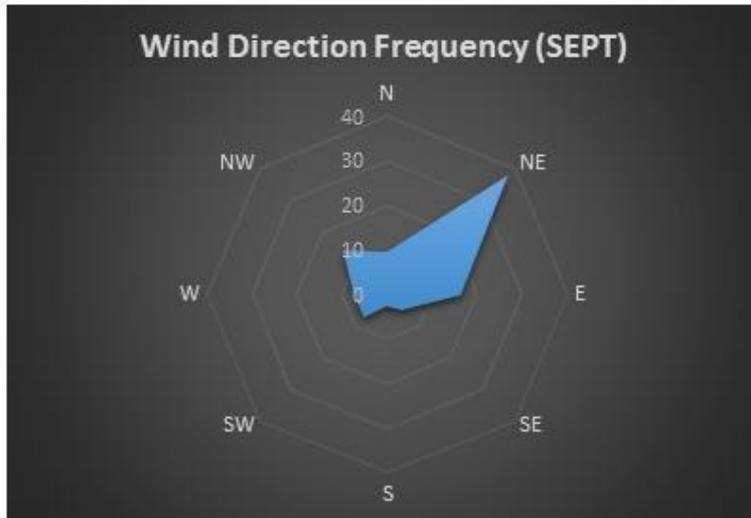
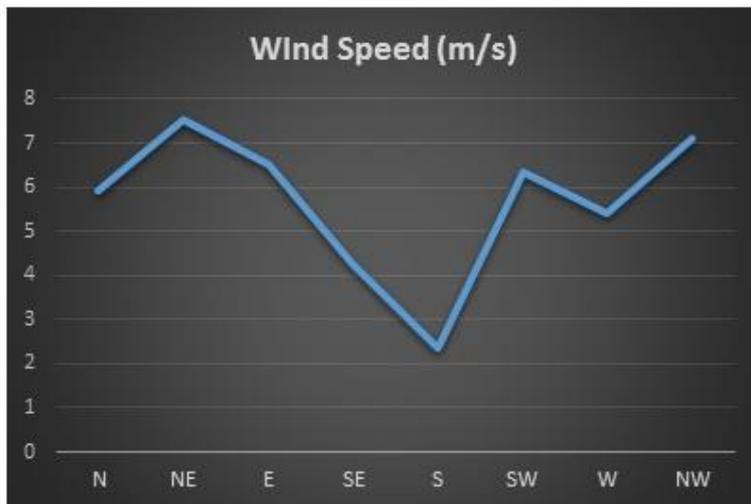
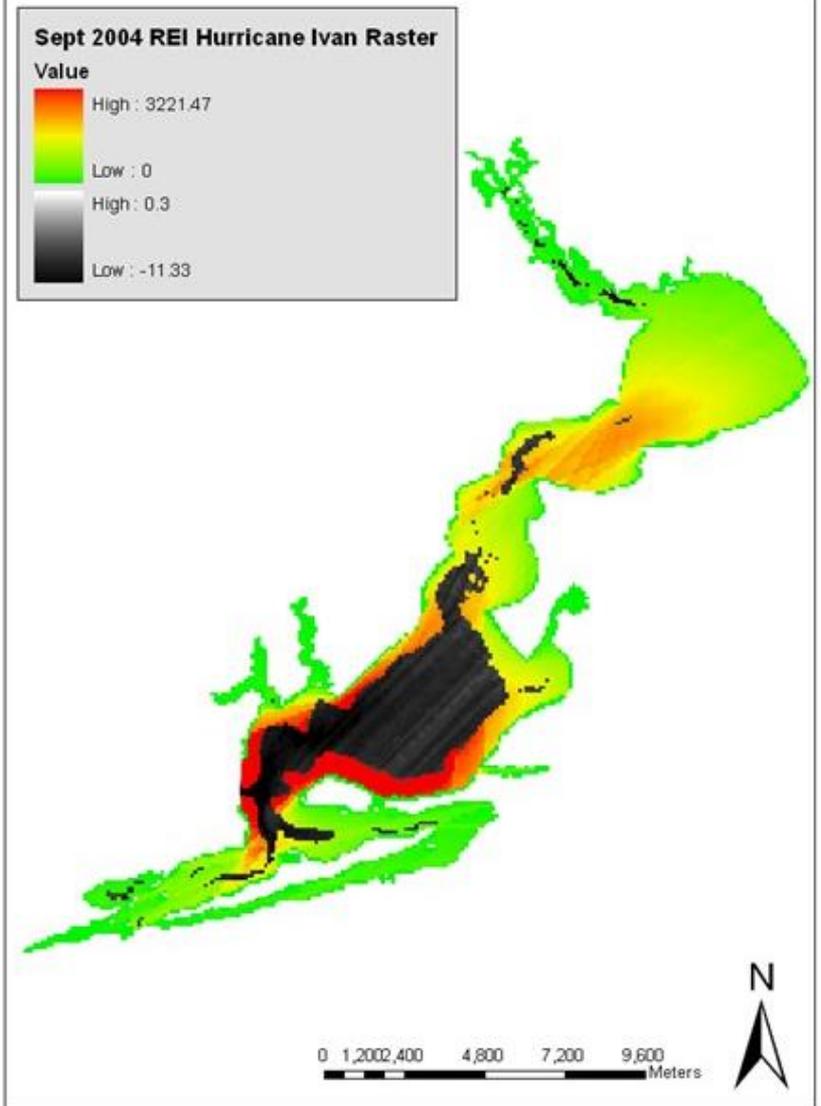
# NOAA Physical Disturbance Model (WEMo)- Perdido Bay, September 2004

## Hurricane Ivan

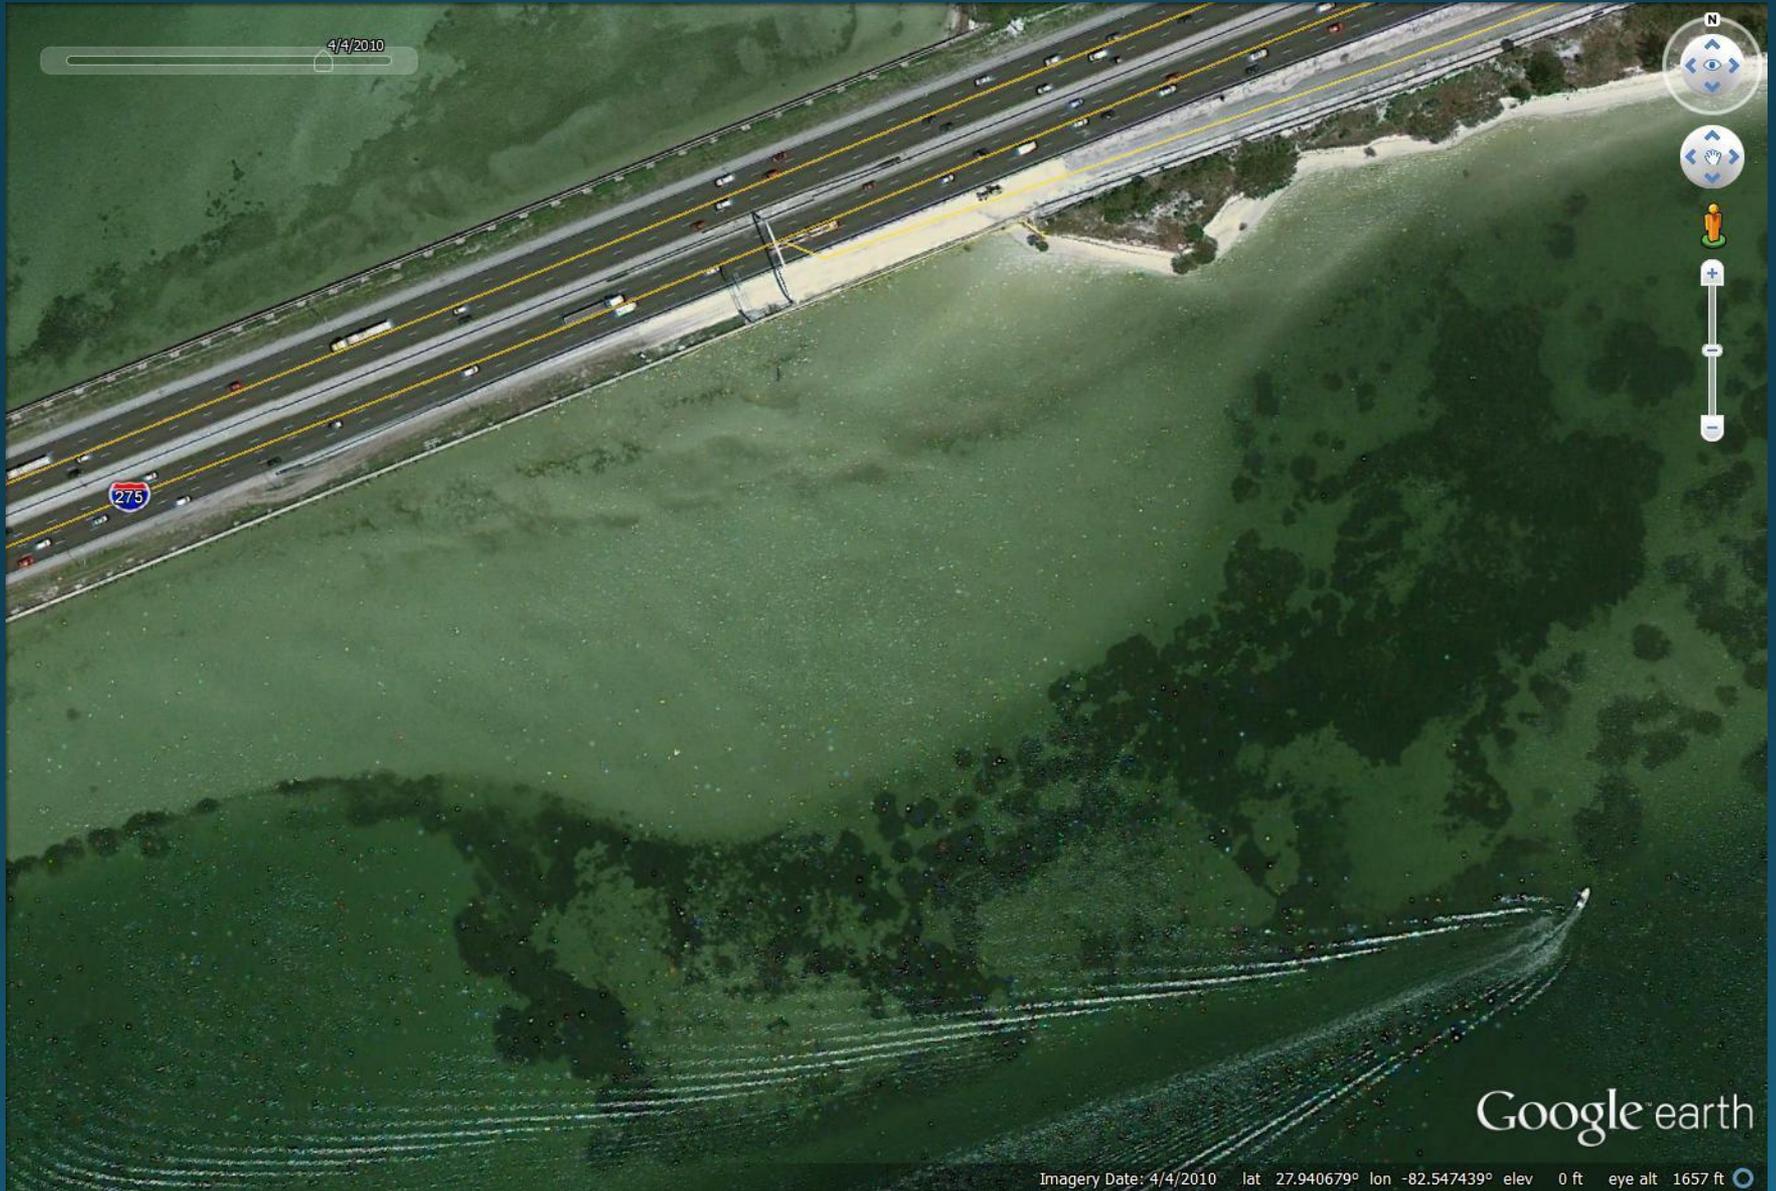
# Example of Wave Action and Erosion Along I-275 in Tampa, April 2010

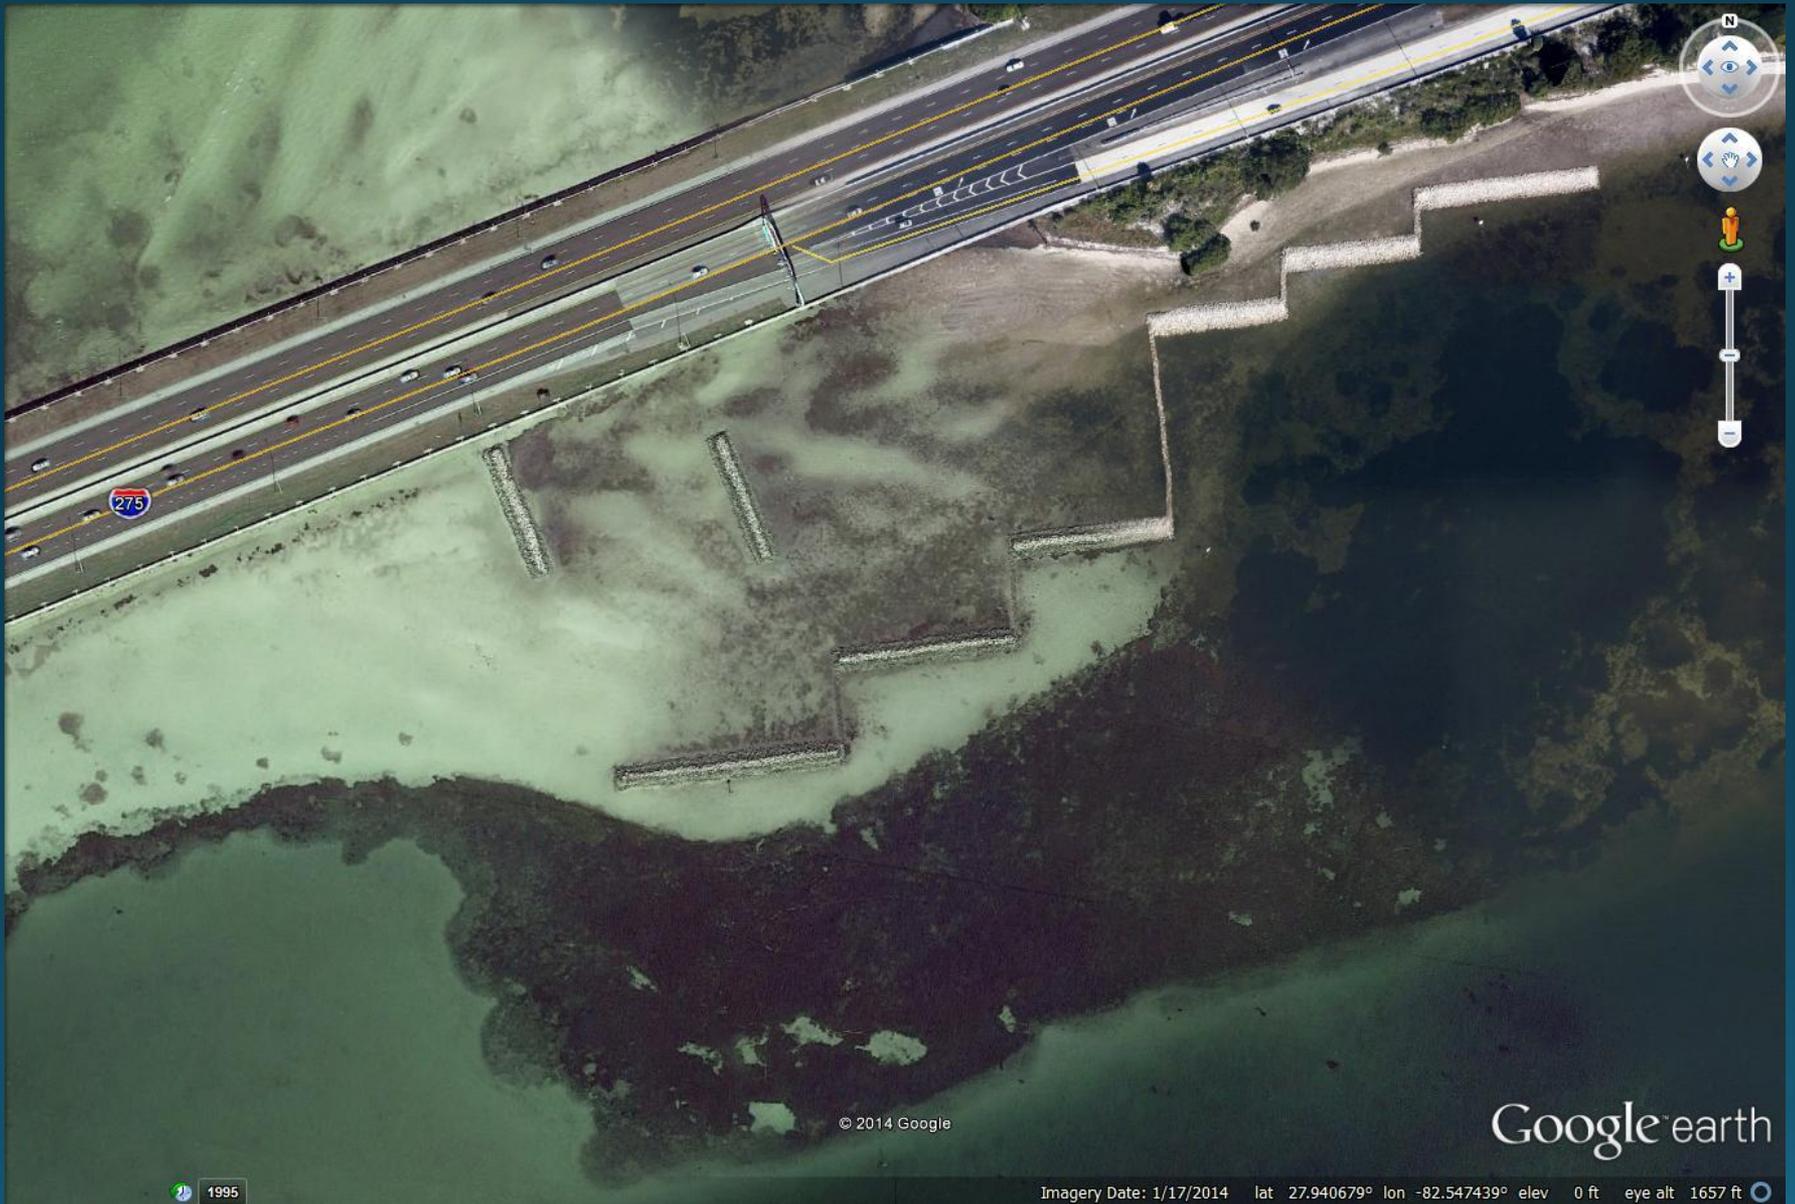
# Effect of Rip Rap Barriers, January 2014

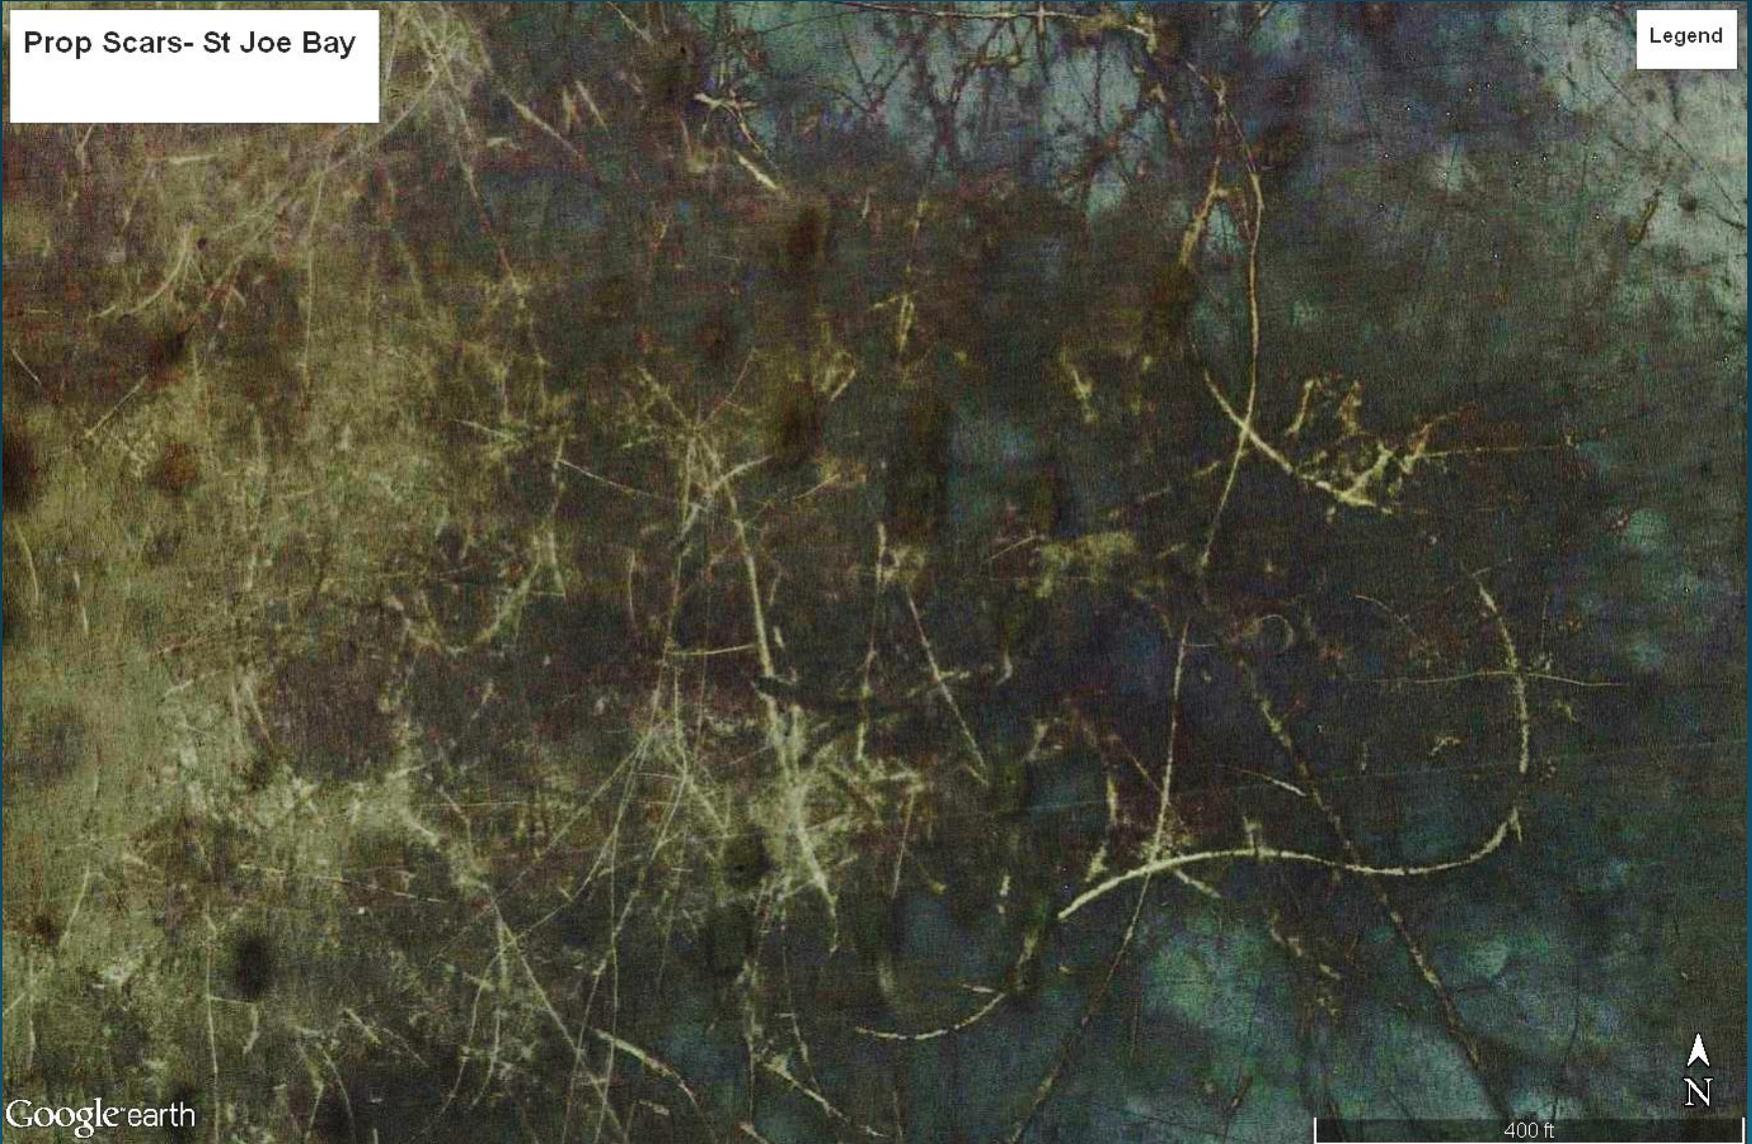
Prop Scars- St Joe Bay

# Human Activity Impacts Include Prop Scarring

## St. Joseph Bay Propeller Scarring

Score	Description	# Cells	% of vegetated cells
9	Bare bottom visible	1056	
0	Vegetated, no scars	1998	57.3%
1	1-2 scars	646	18.5%
2	3-10 scars	466	13.4%
3	11-25 scars	265	7.6%
4	>25 scars	81	2.3%
5	Cell mostly scarred	29	0.8%
	Total scarred cells	1487	42.7%
	Total vegetated cells	3485	
	Sun Glare	248	
	Unreadable	15	
	Too Deep	2709
