# Roadblocks to Seagrass Recovery: Seagrass Restoration Planning

Panama City, February 12, 2016

1. Identify obstacles to seagrass recovery and expansion in target estuaries
2. Develop a GIS Seagrass Recovery Potential (SRP) model of potential stressors and obstacles to recovery and spread in each estuary
3. Use SRP model to identify candidate areas, methods, tools, and projects for successful seagrass recovery and enhancement.

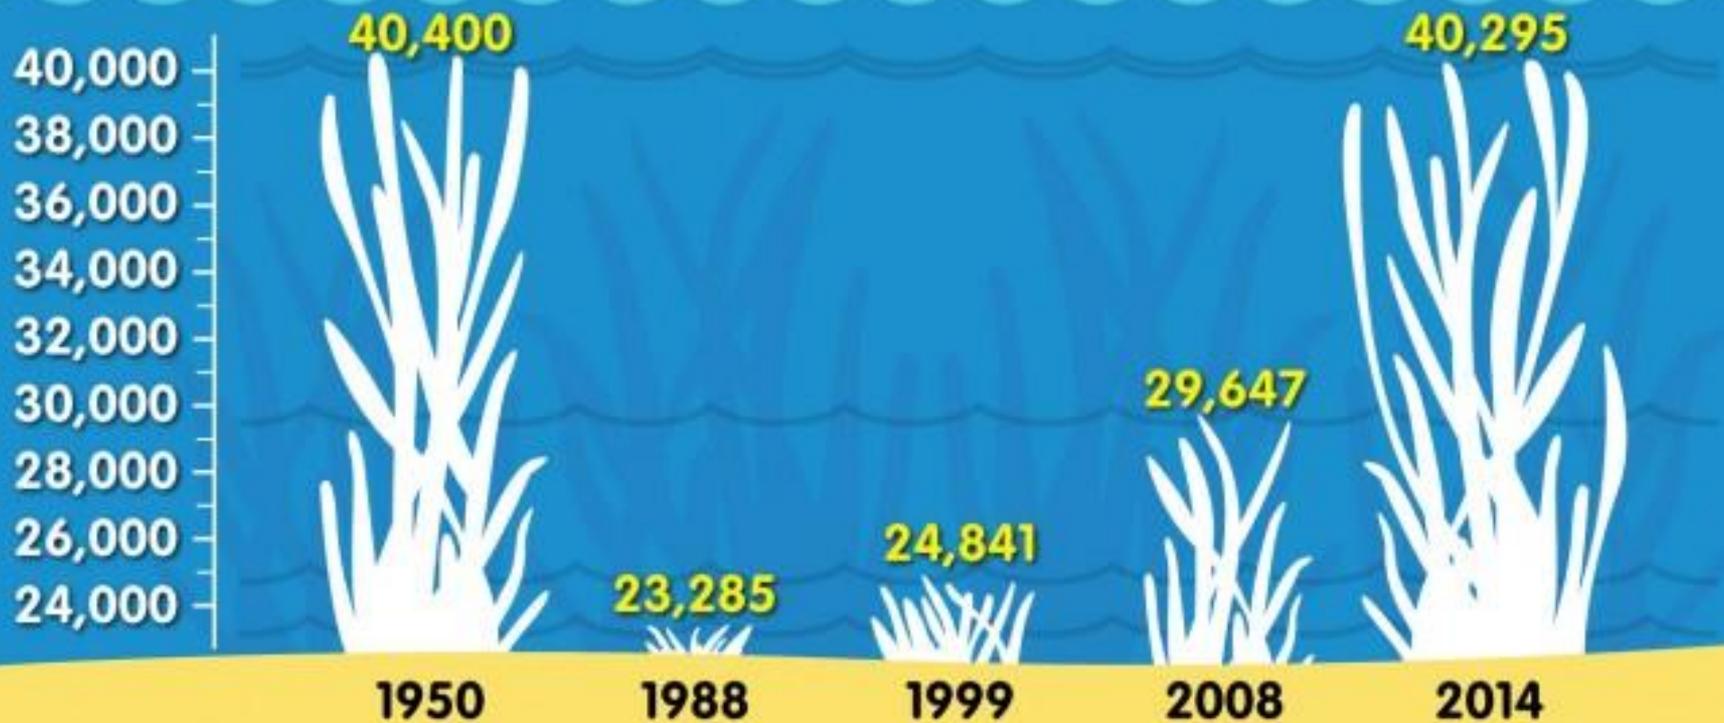
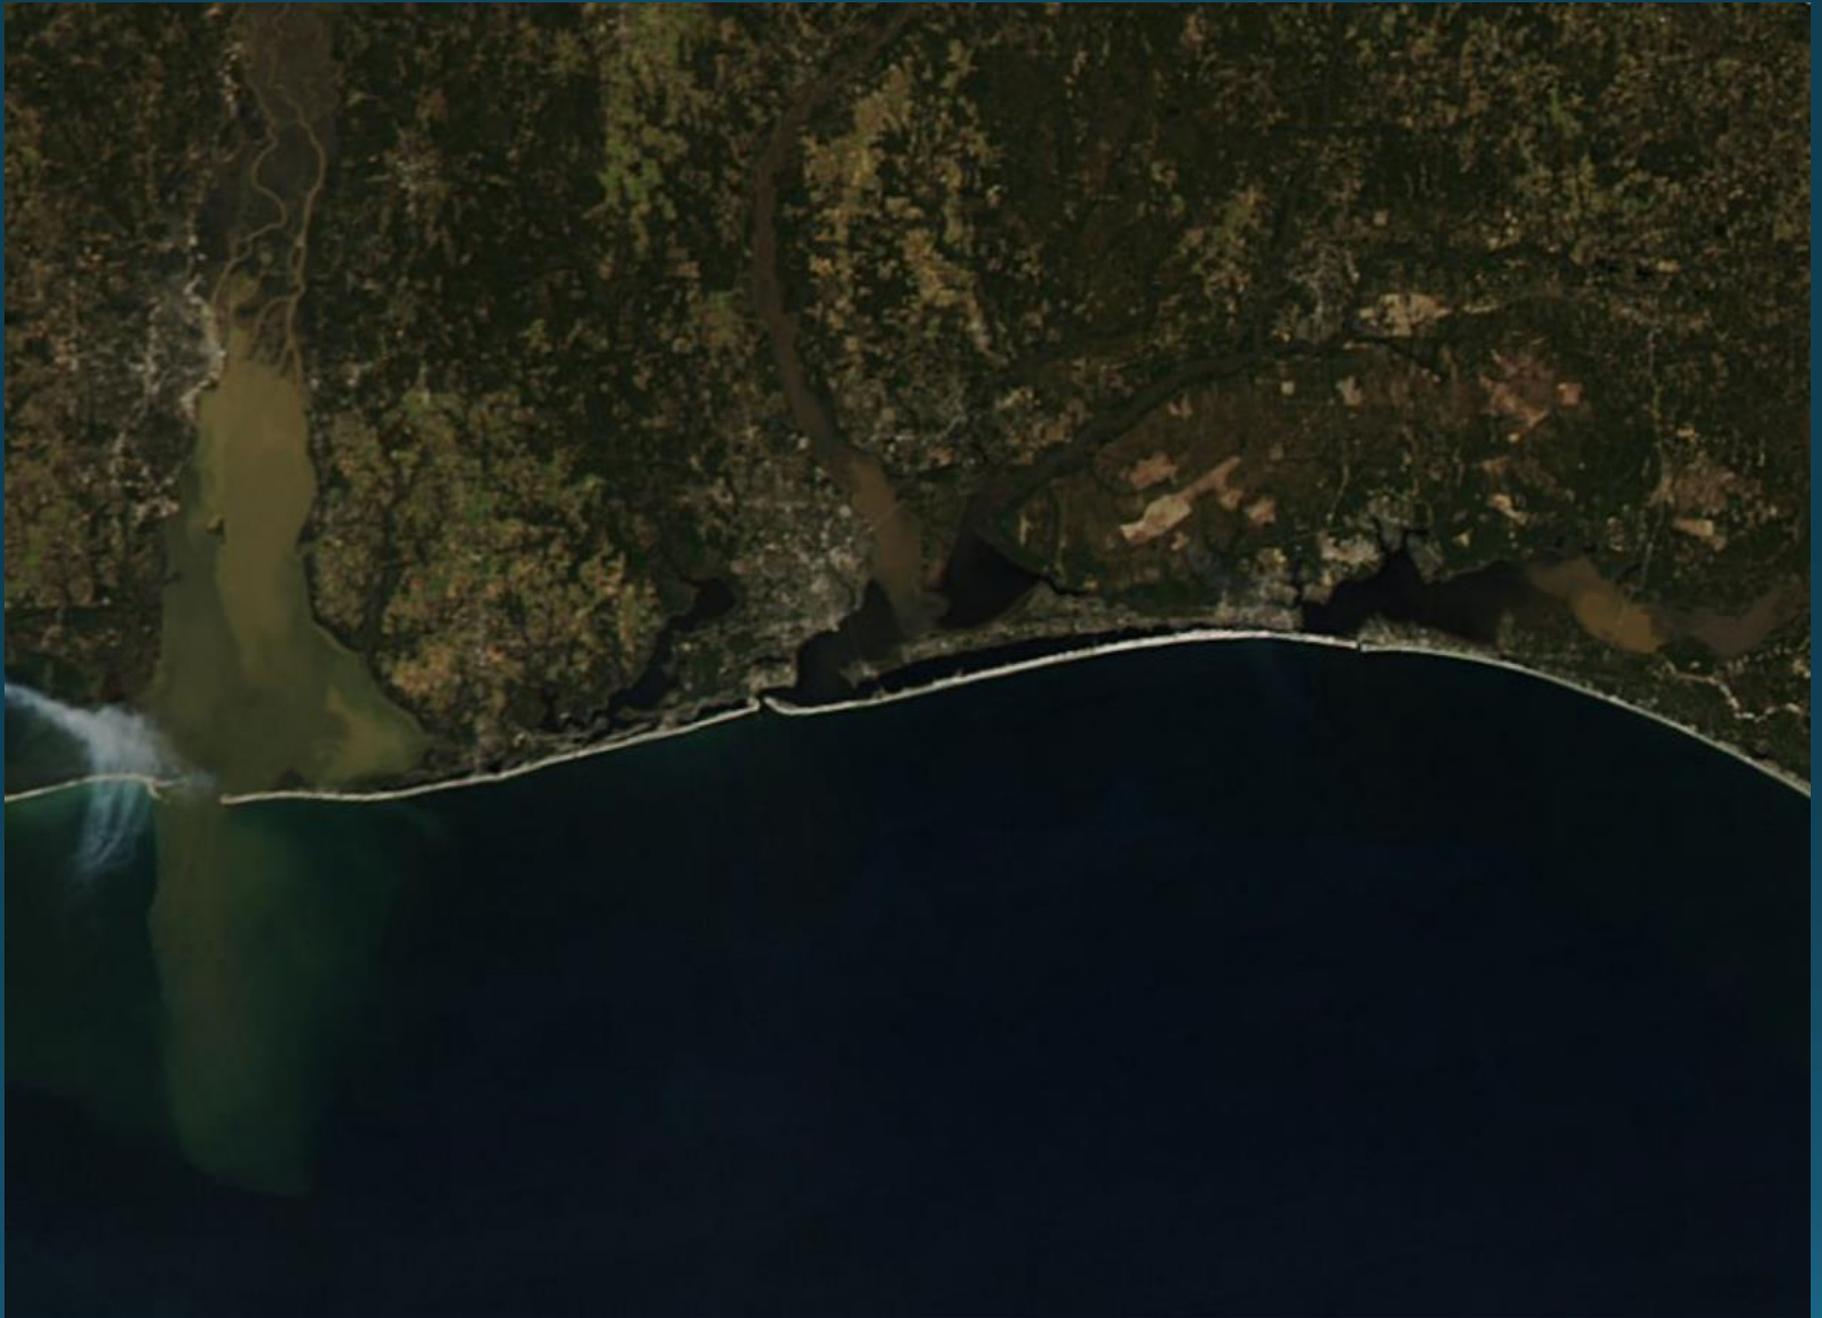
# Seagrass Changes in Tampa Bay
